## 5. Historic Development

## 5. HISTORIC DEVELOPMENT

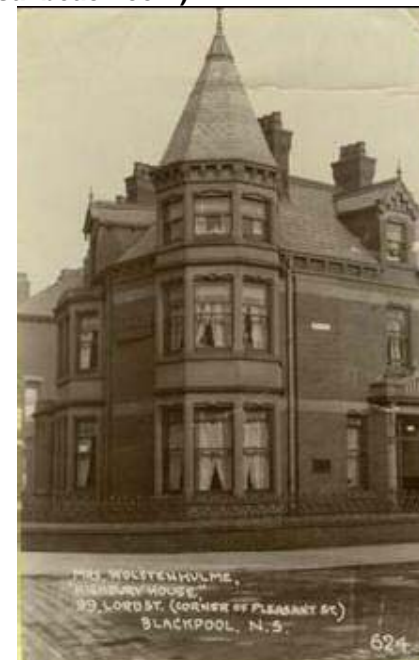
**Figure 24: Prominent Boarding House on Lord Street c.1900 (from [www.rossallbeach.com](http://www.rossallbeach.com))**

- 5.7 The spurt of development in the 1960s was short-lived and later development was aimed at respectable working class people. Representative of the 1860s and 1870s phase of development are a few terraces of handsome lodging houses (Figure 24) on the roads closest to the sea, such as the western end of Banks Street, Cocker Street, Wilton Parade and the south end of Dickson Road. Plainer lodging houses were built further inland on streets such as High Street in this phase.

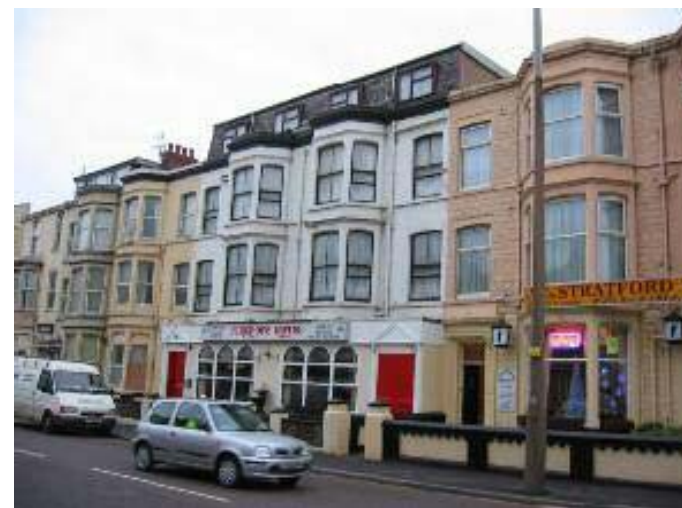
**Figure 25: Typical Lodging Houses on Dickson Road**

- 5.13 The streets west of Dickson Road were developed with larger boarding houses and service buildings on lanes to the rear of Promenade properties (see Figure 25). A few notable public buildings were provided in this area including swimming baths on Cocker Street (1871) (**Figure 26**) and the Grundy Art Gallery and Carnegie Library (opened 1909).

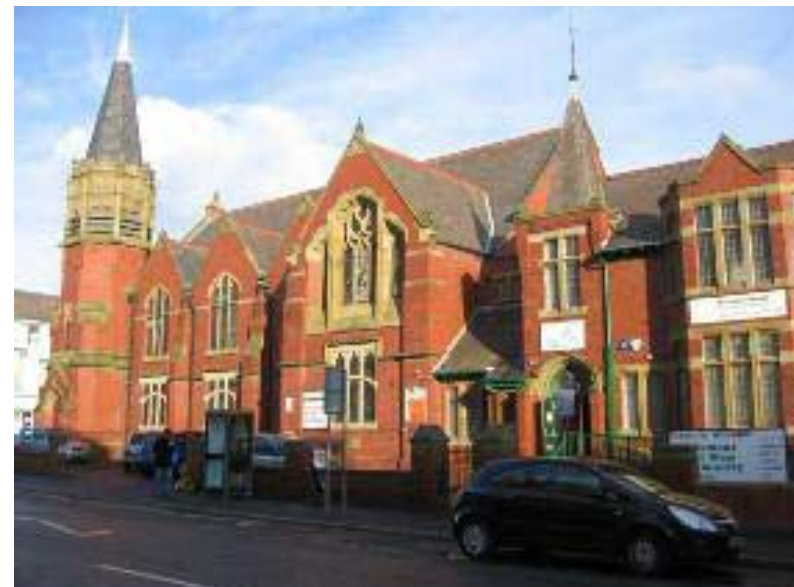
**Figure 27: North Shore Methodist church and former Sunday school, Dickson Road, 1907**

- 5.14 The spiritual needs of the community were met by a range of churches and chapels, including Christchurch on Queen Street, opened in 1871 (closed in 1982). Nonconformist chapels and churches on Dickson Road included the Mount Pleasant Wesleyan Chapel, first built in 1888 on the corner of Cocker Street and replaced by the present Methodist Church and school rooms in 1907 (Figure 27) and on the same side of the road, the Unitarian Church which opened in the 1883. The Baptist Tabernacle and Sunday school were built at the west end of Springfield Road in 1904.

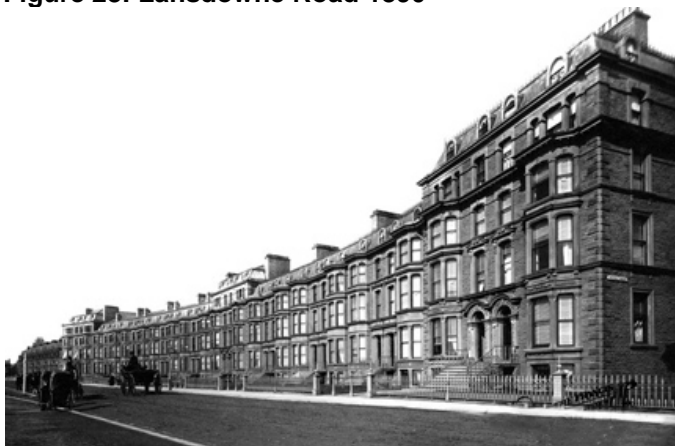
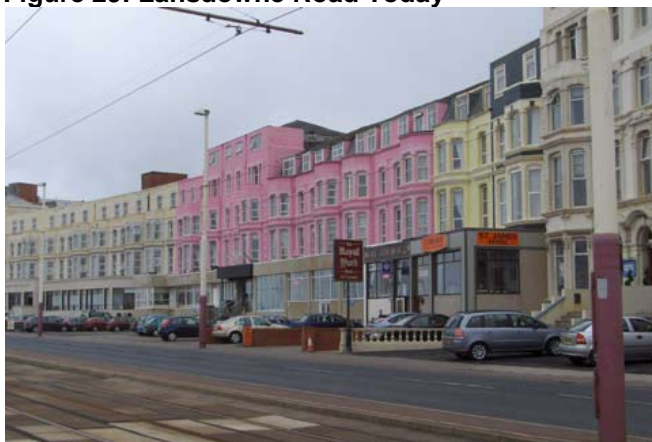
**Figure 28: Lansdowne Road 1890**

- 5.23 The historic and present day photographs of Lansdowne Crescent (Figure 28 and Figure 29) indicate the extent of modification and additions that the buildings have received. This is typical of the whole of the North Beach area, and in many cases, the quality of the buildings has been degraded.

- 5.22 At a detailed level there has been a high degree of alteration, particularly to doors, windows and shop fronts. Many of the lodging houses on streets closest to the sea have been altered with roof extensions and ground floor additions over front gardens, but this type of change is not as prevalent or as intrusive as in South Shore or in Bloomfield, for example. Front garden walls are generally still in situ along residential streets with relatively few lost for front parking.

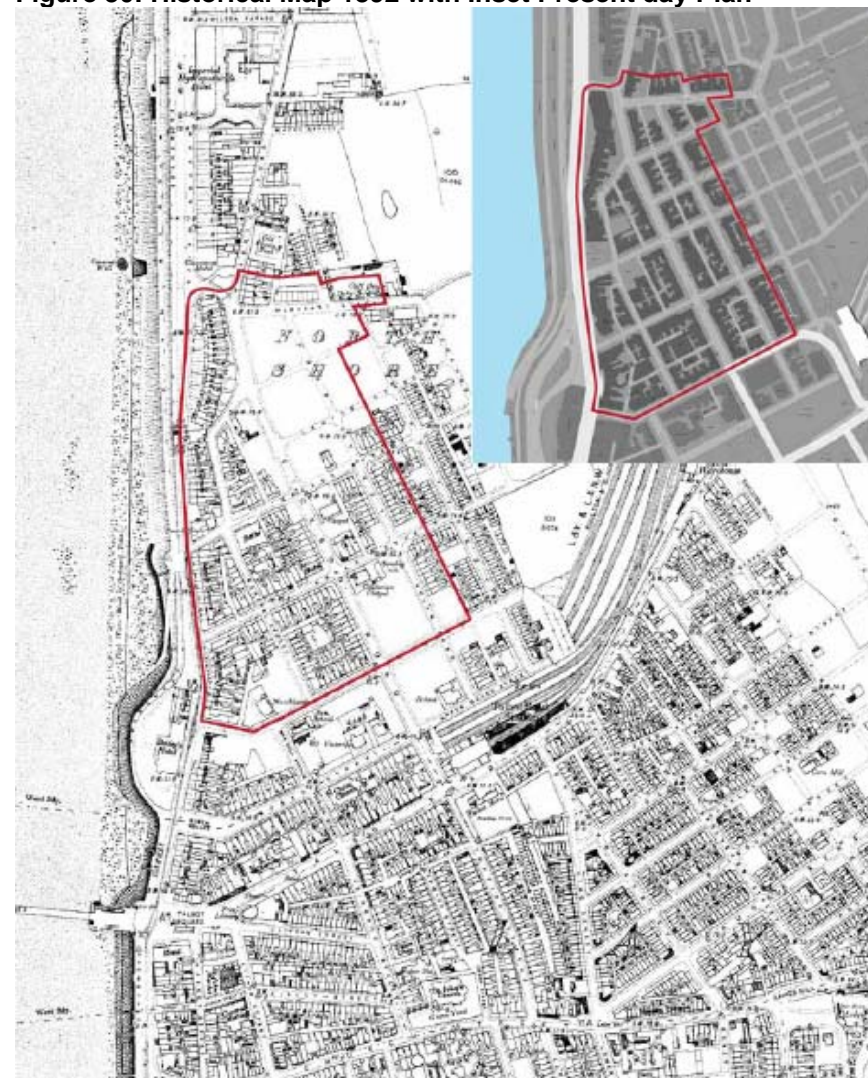
**Figure 30: Historical Map 1892 with Inset Present day Plan**

- 5.10 The historic map of 1892 illustrated in Figure 30 indicates the following:
- The tight grid network of streets present within North Beach was already established by 1892, and has remained largely unchanged. Although not yet fully developed by 1892, the development plots were already clearly laid out.
  - In 1892 there was a mixture of building usage within the North Beach area. A mix of uses is also present within the North Beach area today. The map indicates residential usage,

hotels, and public facilities such as public baths, a post office and chapels/schools. A skating rink is located to the immediate north of the site boundary. The demolition of some of these facilities has resulted in the current ground level parking areas in Cocker Square.

- Direct access to the railway station was formerly available via Dickson Road, due to the orientation and position of the previous railway station building.
- Some of the landmark buildings currently present within North Beach and the immediately surrounding areas are also evident as distinctive buildings on the 1892 map. These include Lansdowne Crescent; the Metropole Hotel (formerly Bailey's Hotel) to the immediate south-west of the North Beach site boundary; and the Methodist Church and Unitarian Chapel on Dickson Road.
