# Marton Moss conservation area appraisal

## Marton Moss Conservation Area Appraisal

December 2018

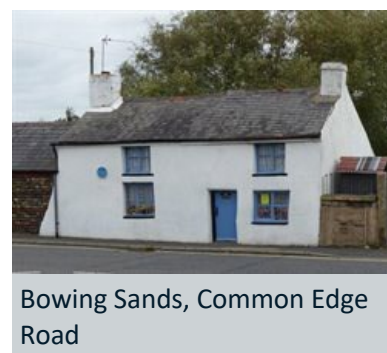
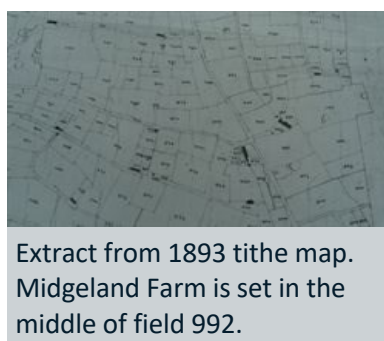
**6.4** Locally listed Midgeland Farm was probably originally completely cobble built and, in its rural setting, is the least compromised of the Marton Moss

historic buildings. The current farmhouse is probably early 19<sup>th</sup> century re-constructed from handmade brick, with earlier attached cobble built barn and shippons with brick patch repairs. Unlike other 'improved' farmhouses, which were usually roofed in slate, Midgeland retains its thatched roof under the damaged asbestos sheeting, which suggests it was one of the earlier sites to be altered. The farmhouse sits on the edge of a former landfill site owned by Lancashire County Council, and is currently in a dilapidated state. It is surplus to the County Council's requirements and potentially at risk of demolition.

**10.1** The cobbled buildings which were once common in this area are now very few in number. Midgeland Farm is a locally listed building which has been allowed to fall into decay. Its repair and conservation should be seen as a high priority as it is one of the key historic buildings in the area.

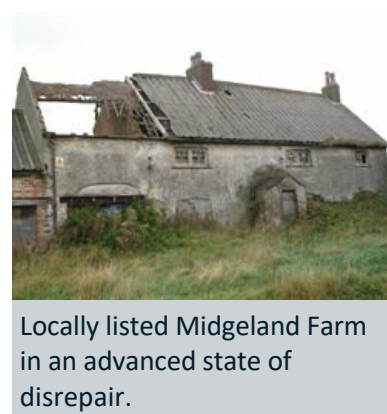
Paddock to north east corner of intersection of School Road and Midgeland Road.

**6.5** The open green spaces to each corner of the nearby intersection of Midgeland Road and School Road are the remnants of the fields which were

farmed by the historic owners and tenants of Midgeland Farm.

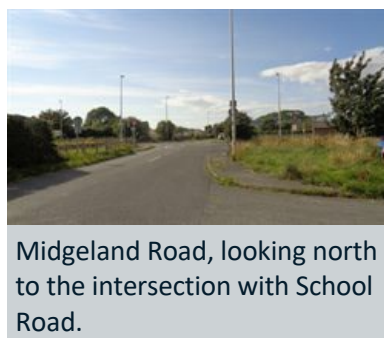
Paddock to south west corner of intersection of School Road and Midgeland Road.

**8.2** The open land at the intersection with School Road has a variety of boundary treatments. The south west paddock is surrounded by timber fencing whilst the paddock to the north east has concrete railing which is missing in places.

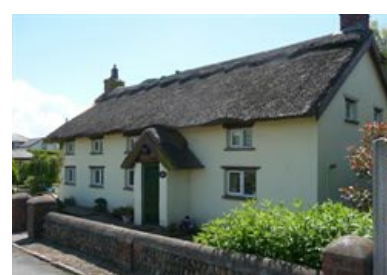
Butchers Farm Cottage, Worthington Road.

**6.6** The locally listed Butcher's Farm Cottage on Worthington Road is late 19<sup>th</sup> century but maintains the Moss tradition of thatched roof covering.

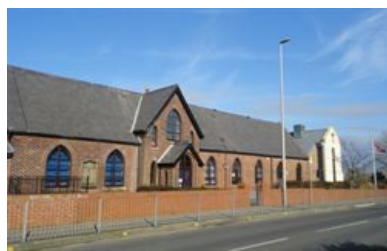
St Nicholas School

which forms the intersection with Midgeland Road, originally began as the most westerly section of the historic lane known as Kitty Lane, named after a resident who had a cottage on the lane. By 1893 School Road had been extended in a direct line east and a school built to educate the children of the surrounding farms. The locally listed school was originally named Marton Moss Church of England Day School, but by 1930 it was known as St. Nicholas Mission Church and Day School.
