The Historic Characterisation of Marton Moss

Report No: 0068/01-09

Archaeo-Environment Ltd
Marian Cottage
Lartington
Barnard Castle
County Durham
DL12 9BP

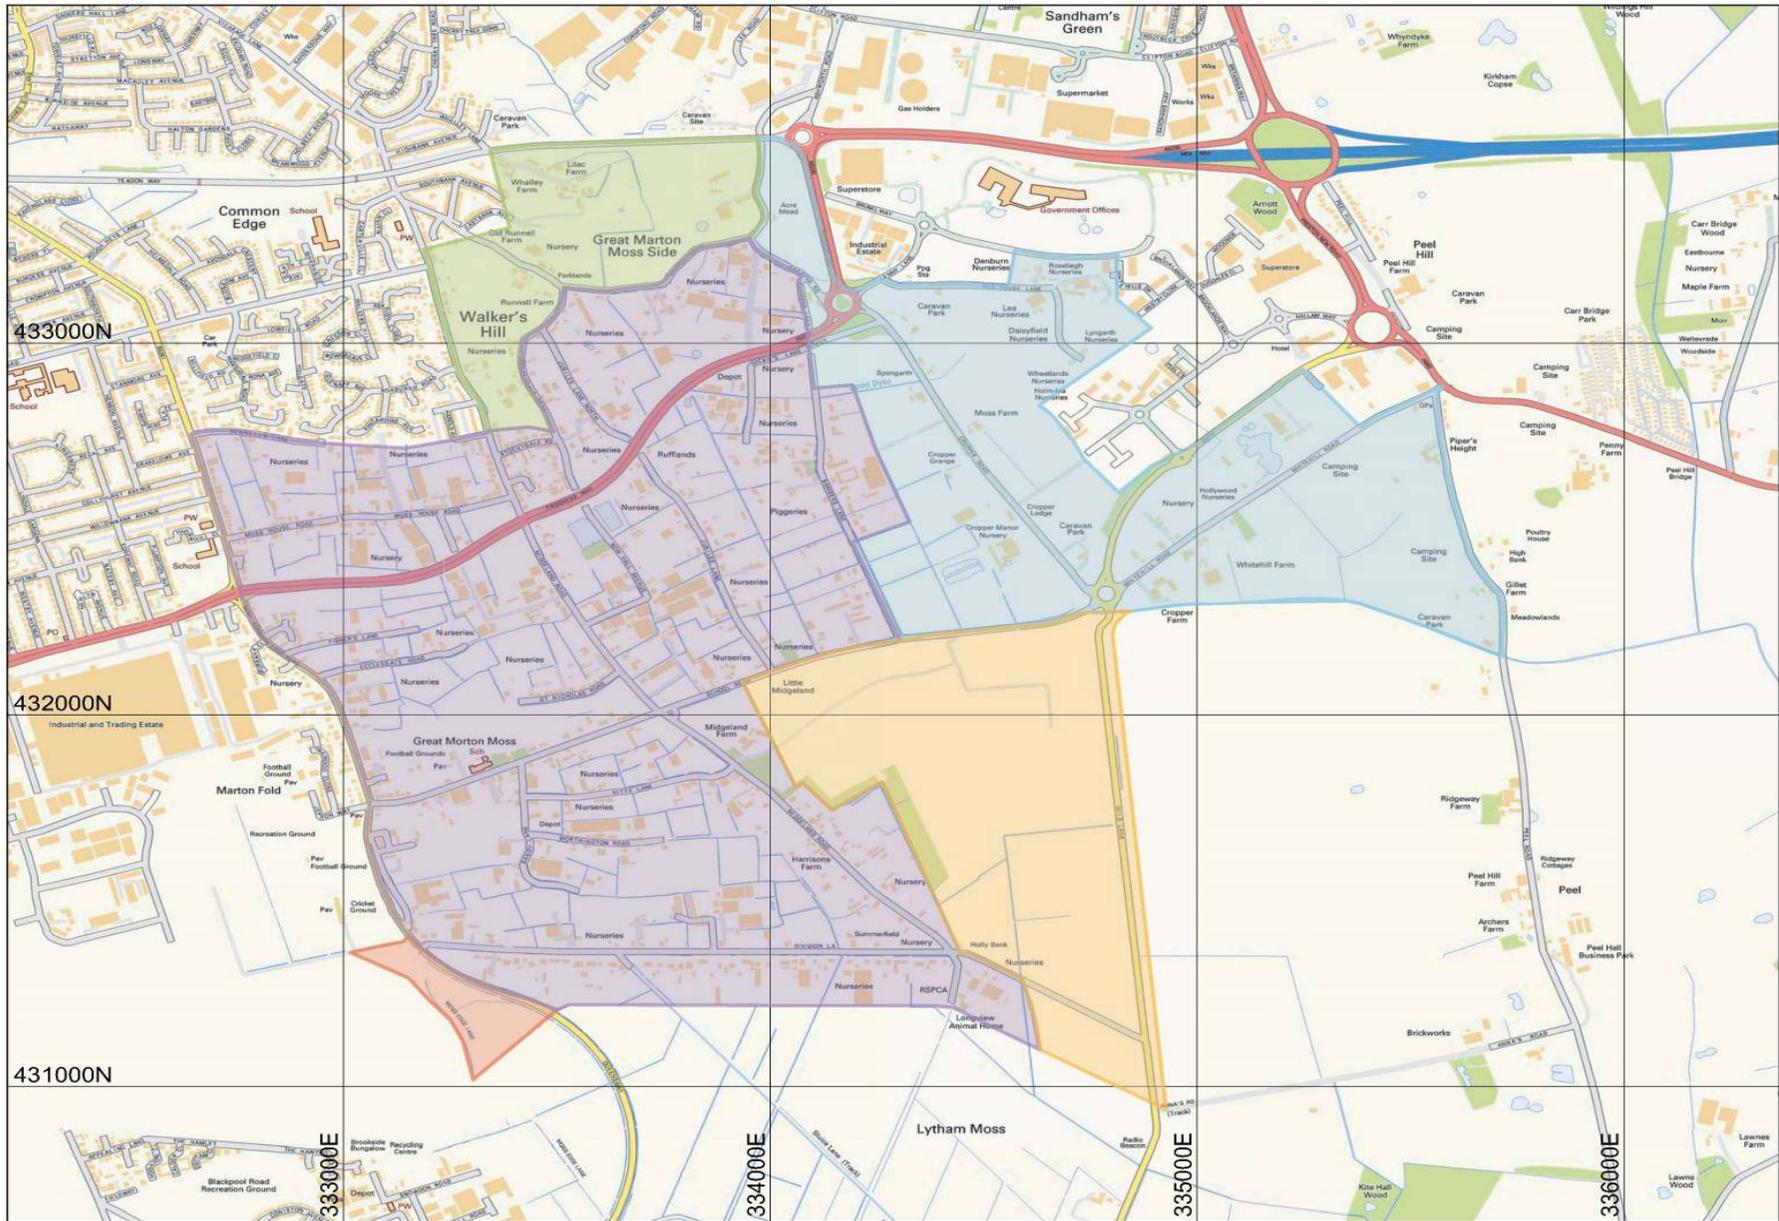
Title: Character Areas
(Combined built environment & historic landscape)

Character Areas
(Combined built environment & historic landscape)

- Area 1
- Area 2
- Area 3
- Area 4
- Area 5

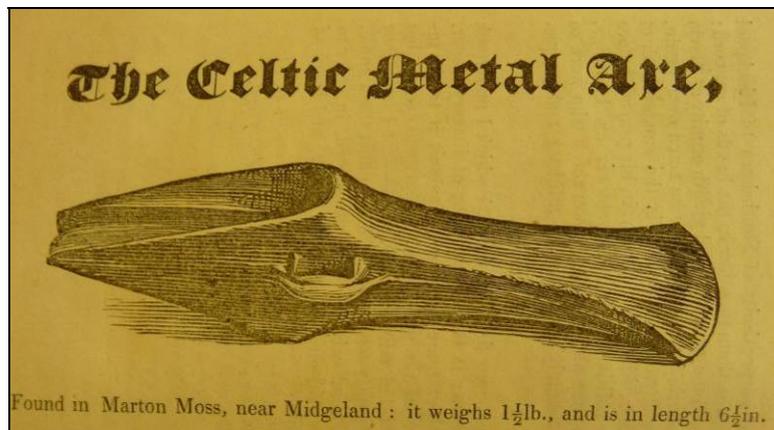
Plate 1. The Bronze Age axe from Midgeland

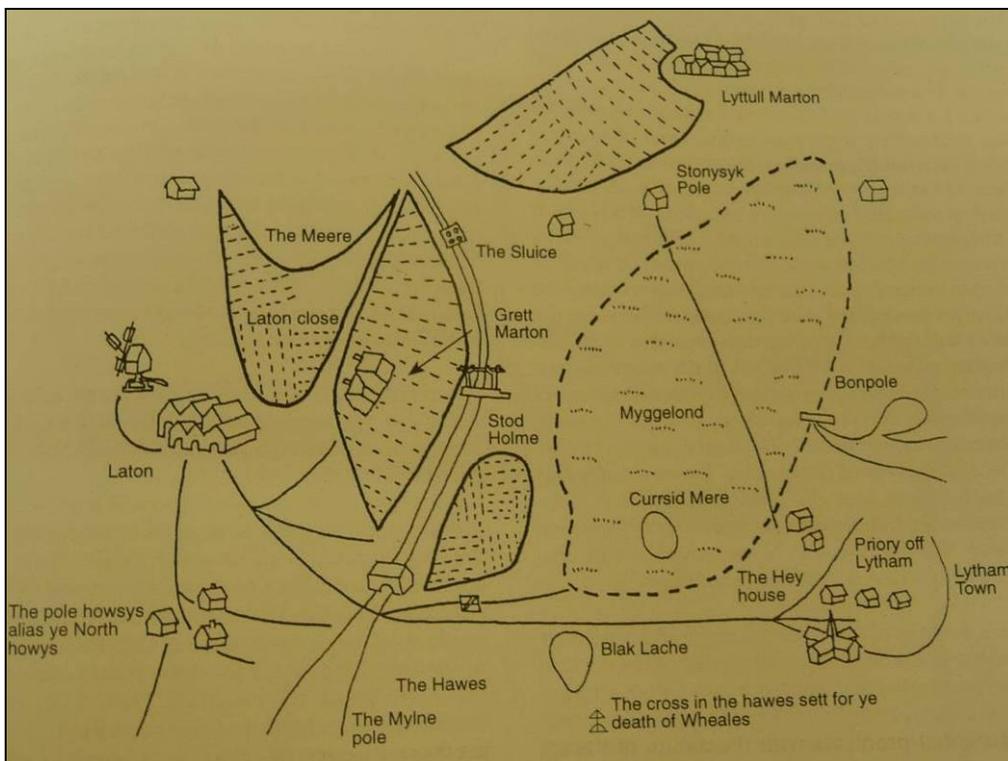
Figure 3. 1532 map of the area (taken from LUAU 1995, 53 and after Winchester). This is very similar to a later map dating to 1700 (see figure 4) and shows the study area to be entirely mossland

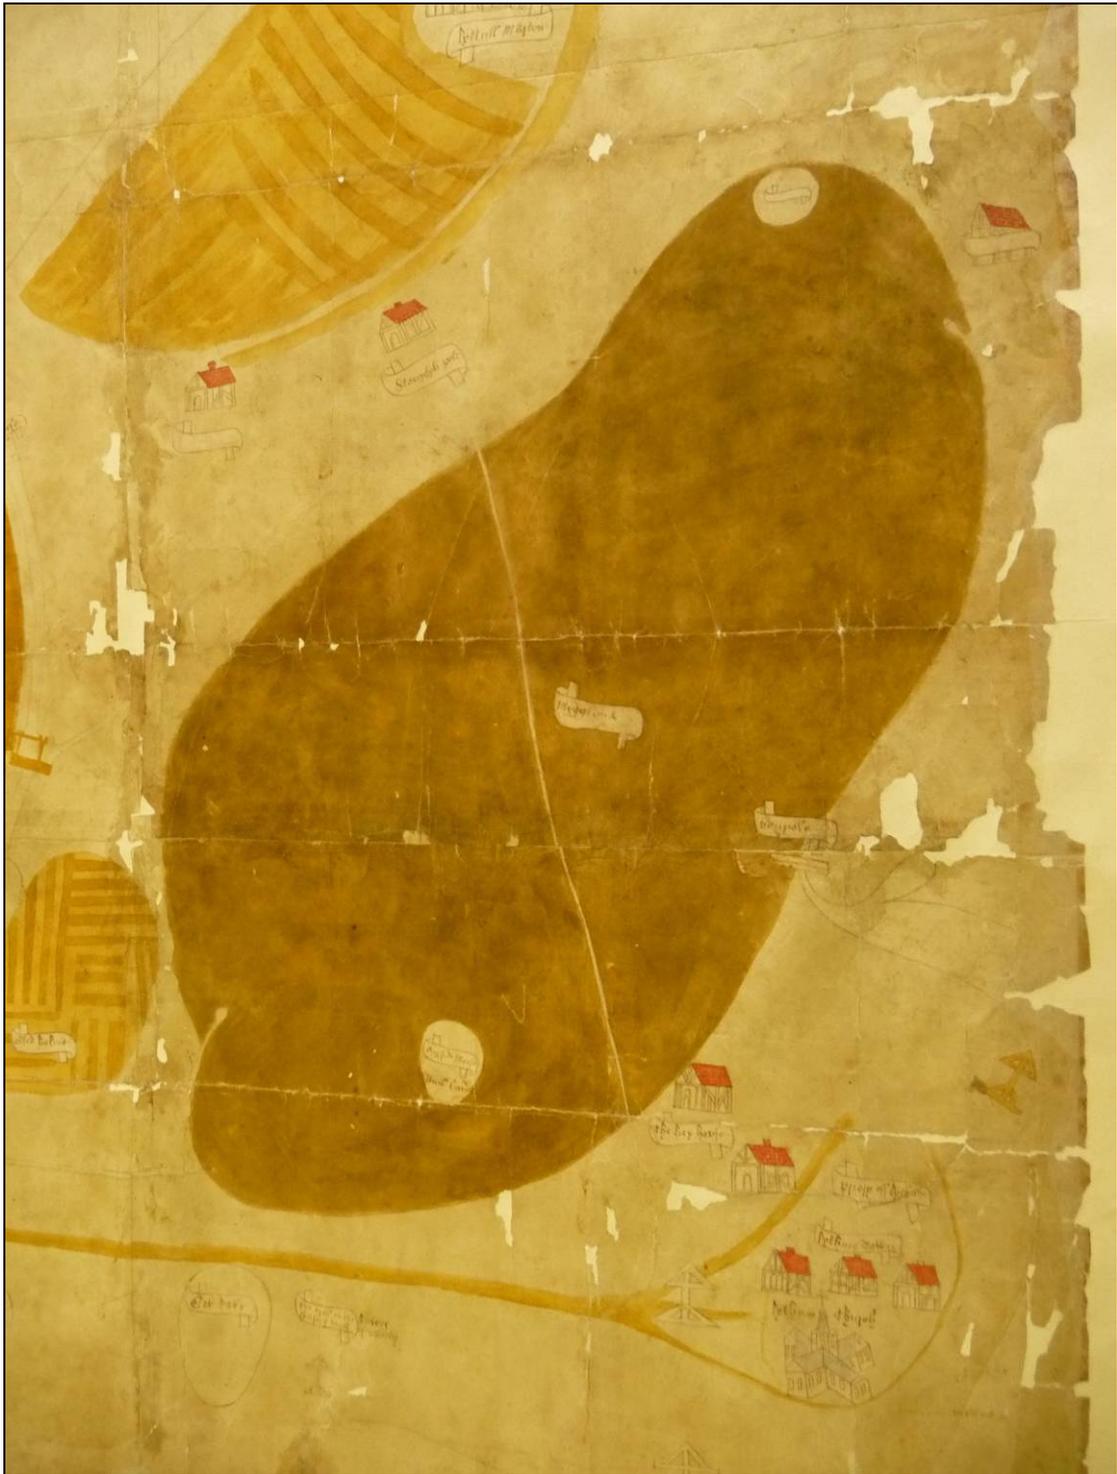
Figure 4. Detail of the mosslands around Midgeland taken from a survey dating to 1700 (LRO DDC1/685). Settlement at this stage is still largely restricted to Lytham and Great and Little Marton with only a few other isolated farms and the hamlet of Heyhouses. The moss is crossed by a road linking Great Marton with Lytham (Midgeland Road) which was also shown on the map of 1532 and a drain runs between the two areas of mossland with a sluice gate. Land on higher ground appears to be under plough.

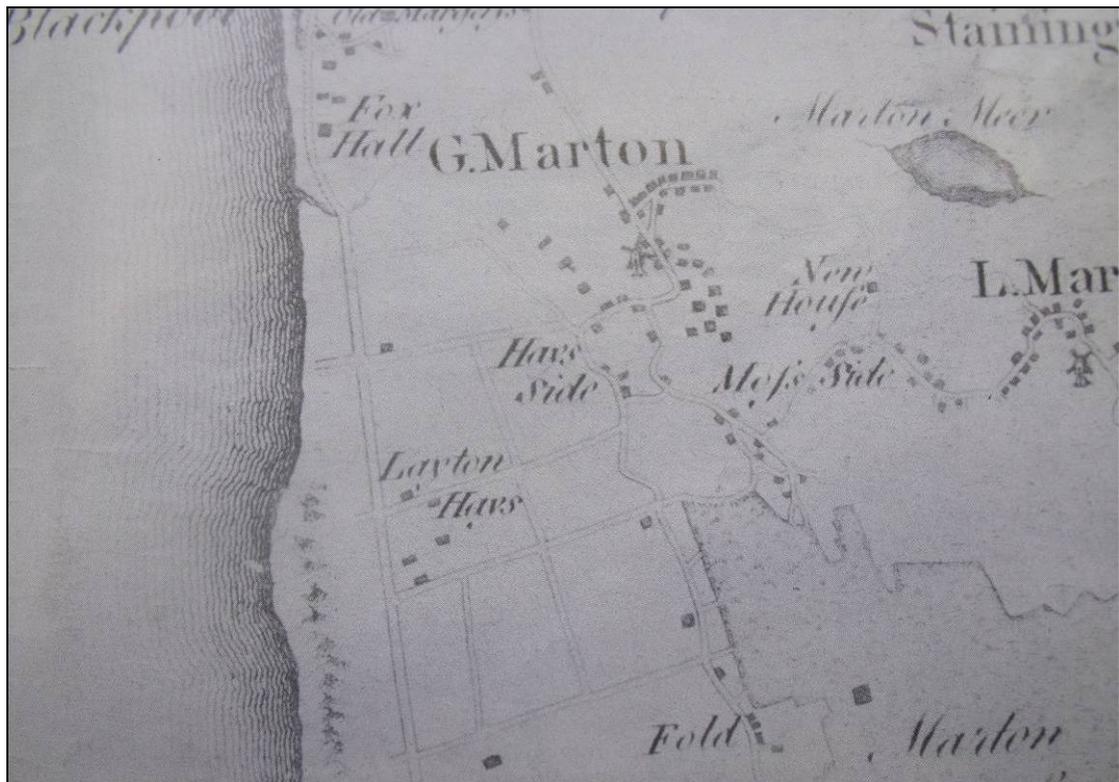
Figure 5. Yates' map of 1786 covering the northern part of the study area showing Common Moss Road with sparse settlement along the road at The Fold and newly laid out fields at Layton Hawes, but the majority of land in the study area is still 'waste' and as yet unenclosed. Great Marton and Little Marton villages have a traditional medieval layout along the roadside. The regularly shaped 'nibbled' edges of the moss suggests that it was being used for peat cutting, increasing the distance between the moss and Moss Side and Fold.

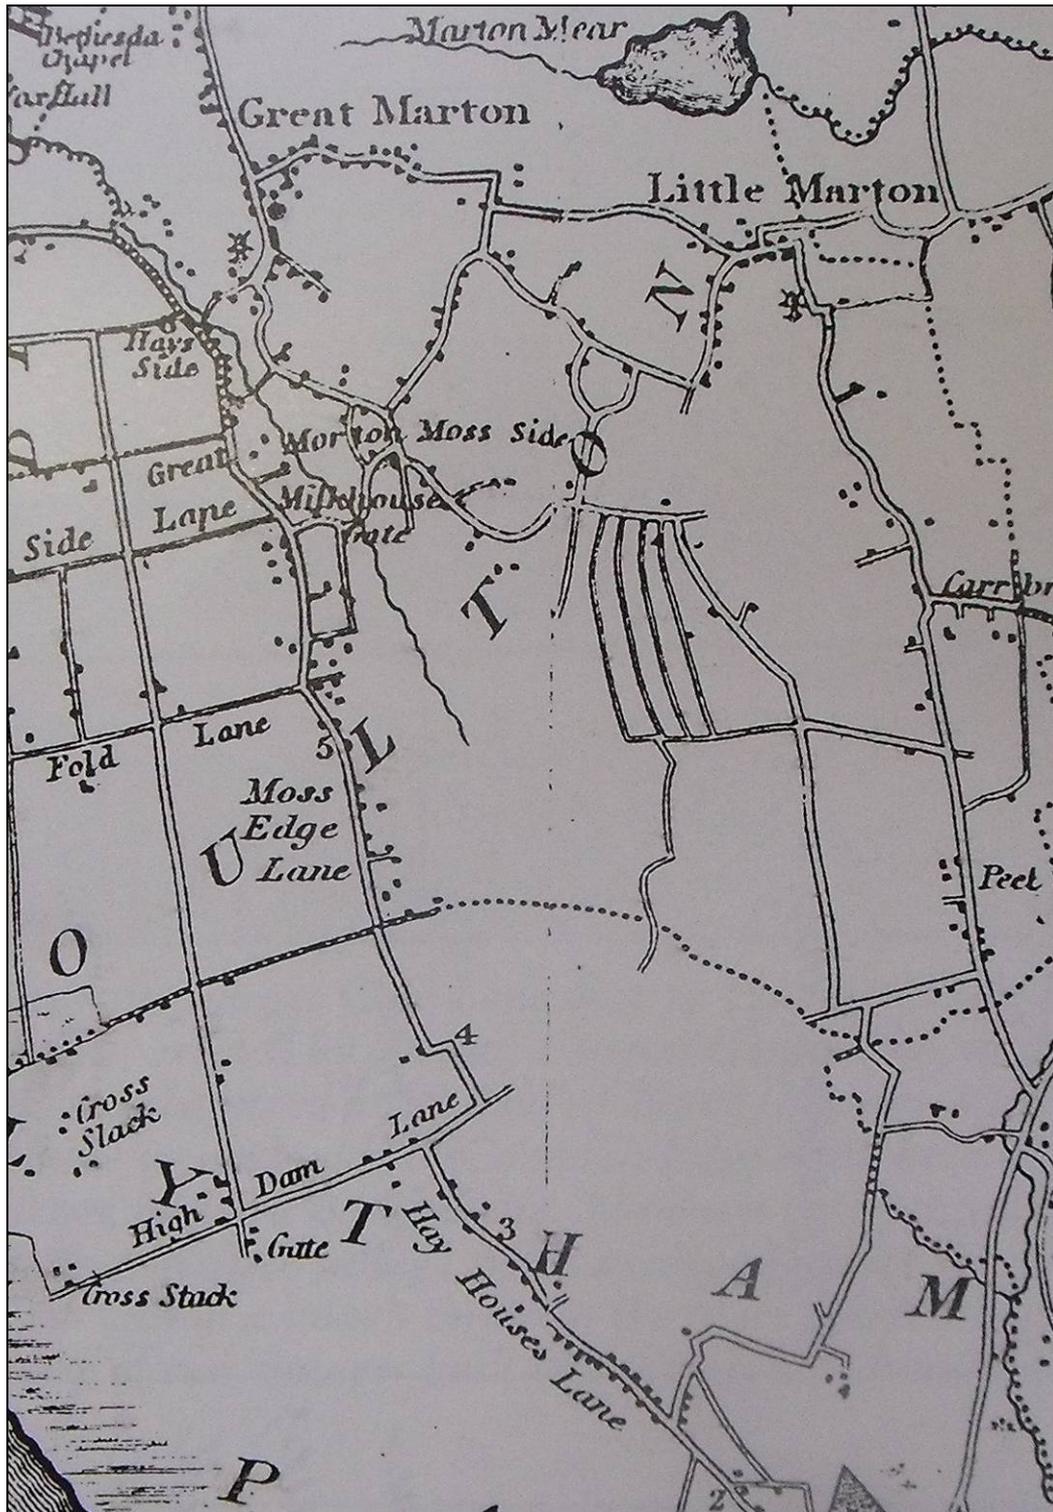
Figure 6. Hennet's map surveyed in 1828/9 showing that land to the west of Moss Edge Lane (as it was then) was subdivided before the mosslands to the east and settlement concentrating along the road sides which hugged drier ground. Windmills are shown to the south of Great Marton and Little Marton. The four regular north south strips below Moss Side may represent the laying out of corridors for peat cutting in advance of further sub-division; alternatively they may be roads being laid out north of School Road. Road improvements were carried out from the 1790s for the Lord of the Manor (Monks 1986, 34). The boundaries of peat cutting corridors may have determined the route of roads

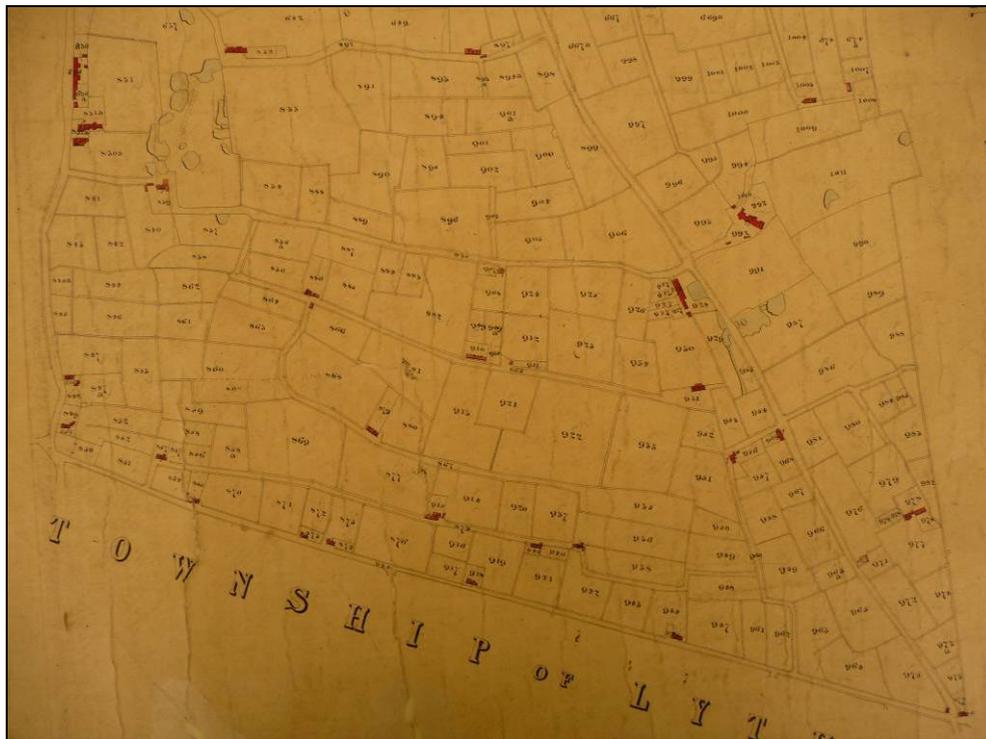
Figure 7. Detail of the Tithe Map for Marton dating to 1839 with Division Lane along the bottom and Midgeland Road from bottom right to top middle. The enclosure pattern of small fields and road network, aligned east-west, has already been established on the moss. Division Lane was the township boundary and to a certain extent still marks a change in landscape character.

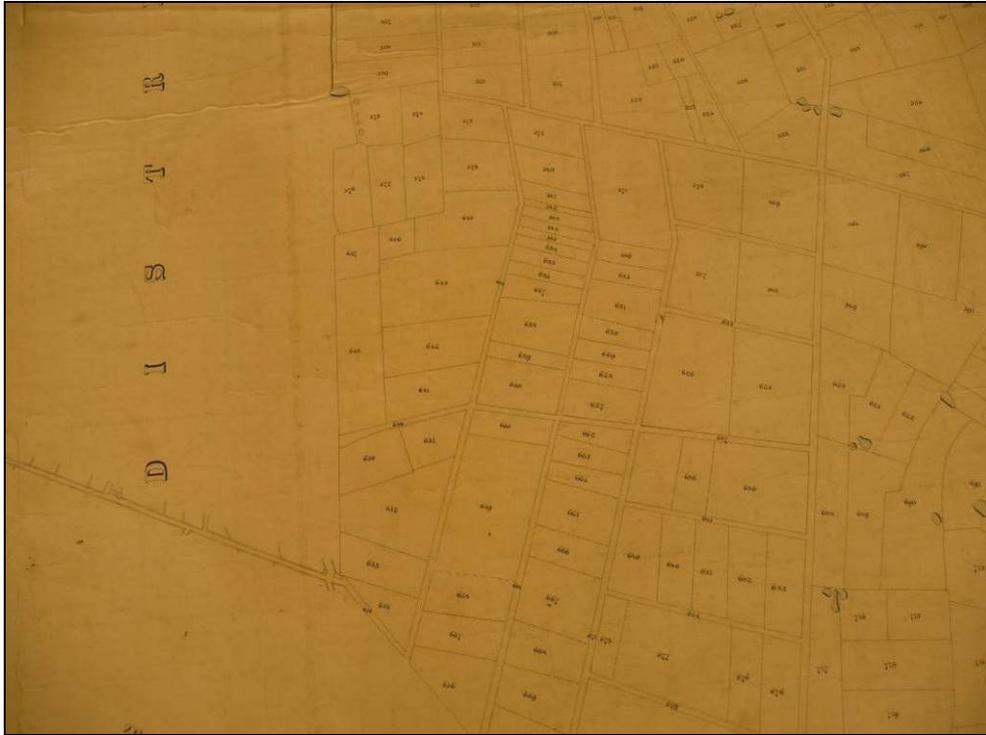
Figure 8. Land east of Midgeland Road (known as Midgeland Lane at the time) has had a different landscape character since 1839 when the Tithe Map was surveyed. Here there are no residences and fields are a more regular pattern based around north-south roads which created a framework for them to develop. A number of the small ladder-like field systems were turbery plots or doles, but these are no longer identifiable on modern maps and barely visible on aerial photographs as a relict field system. The character remains different today between these two areas.

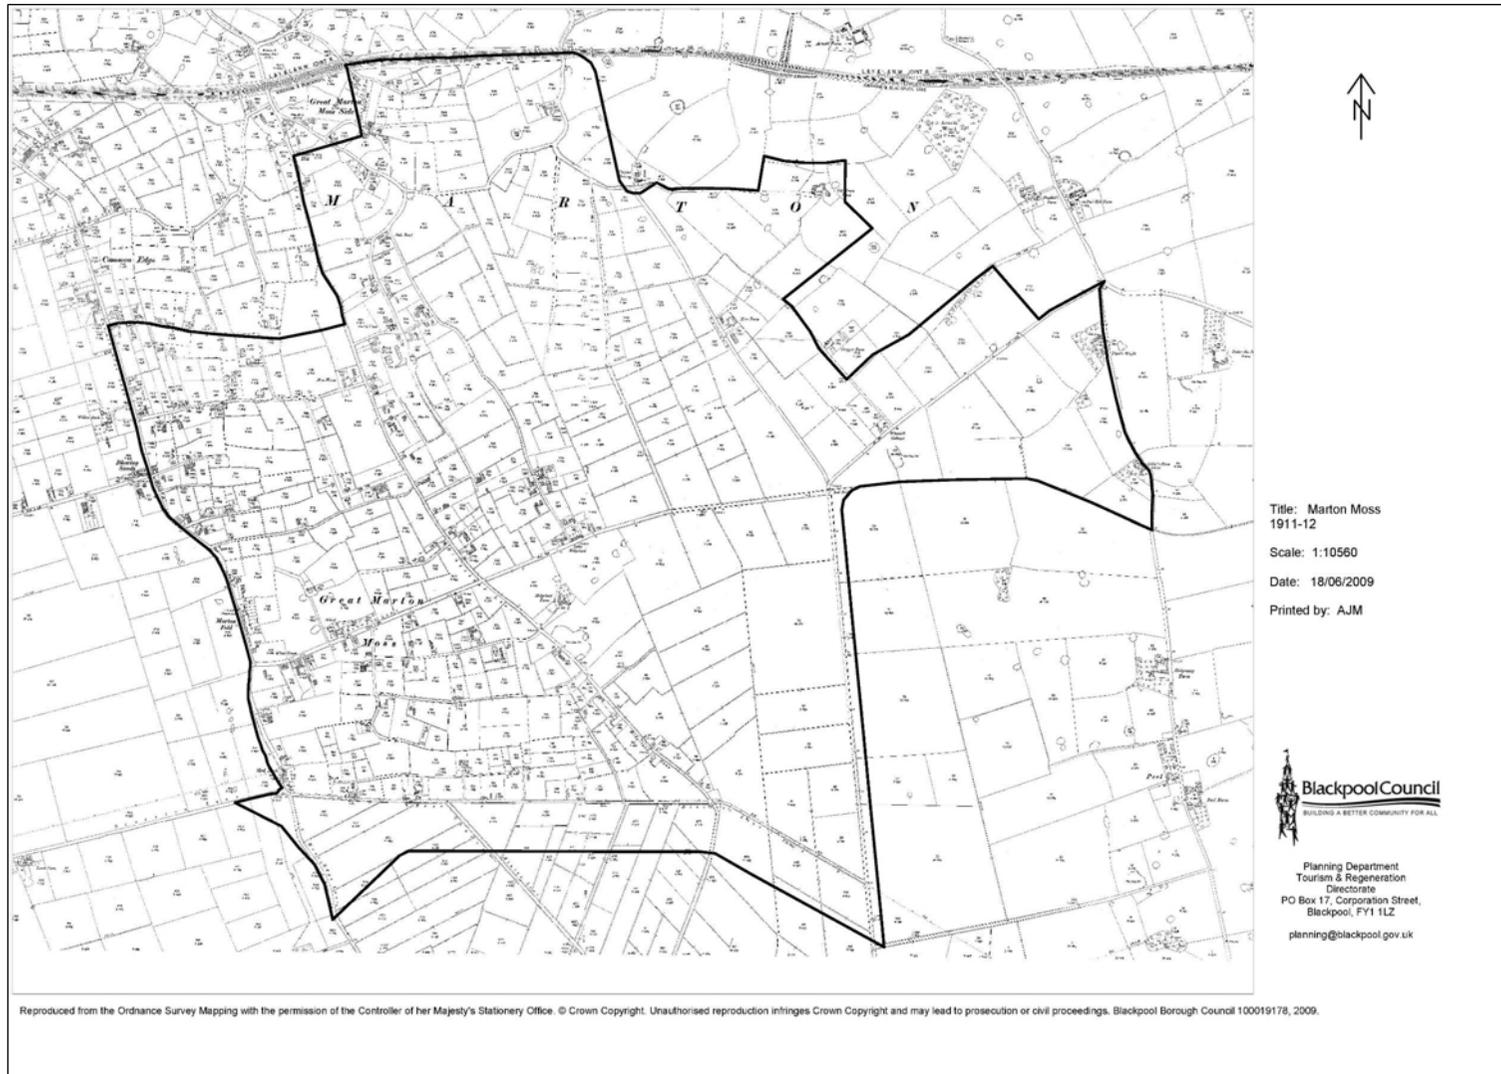
Figure 11. 3rd edition OS map dating to 1911-12 showing the expansion of existing nursery businesses and twin terraces and villas now in place.

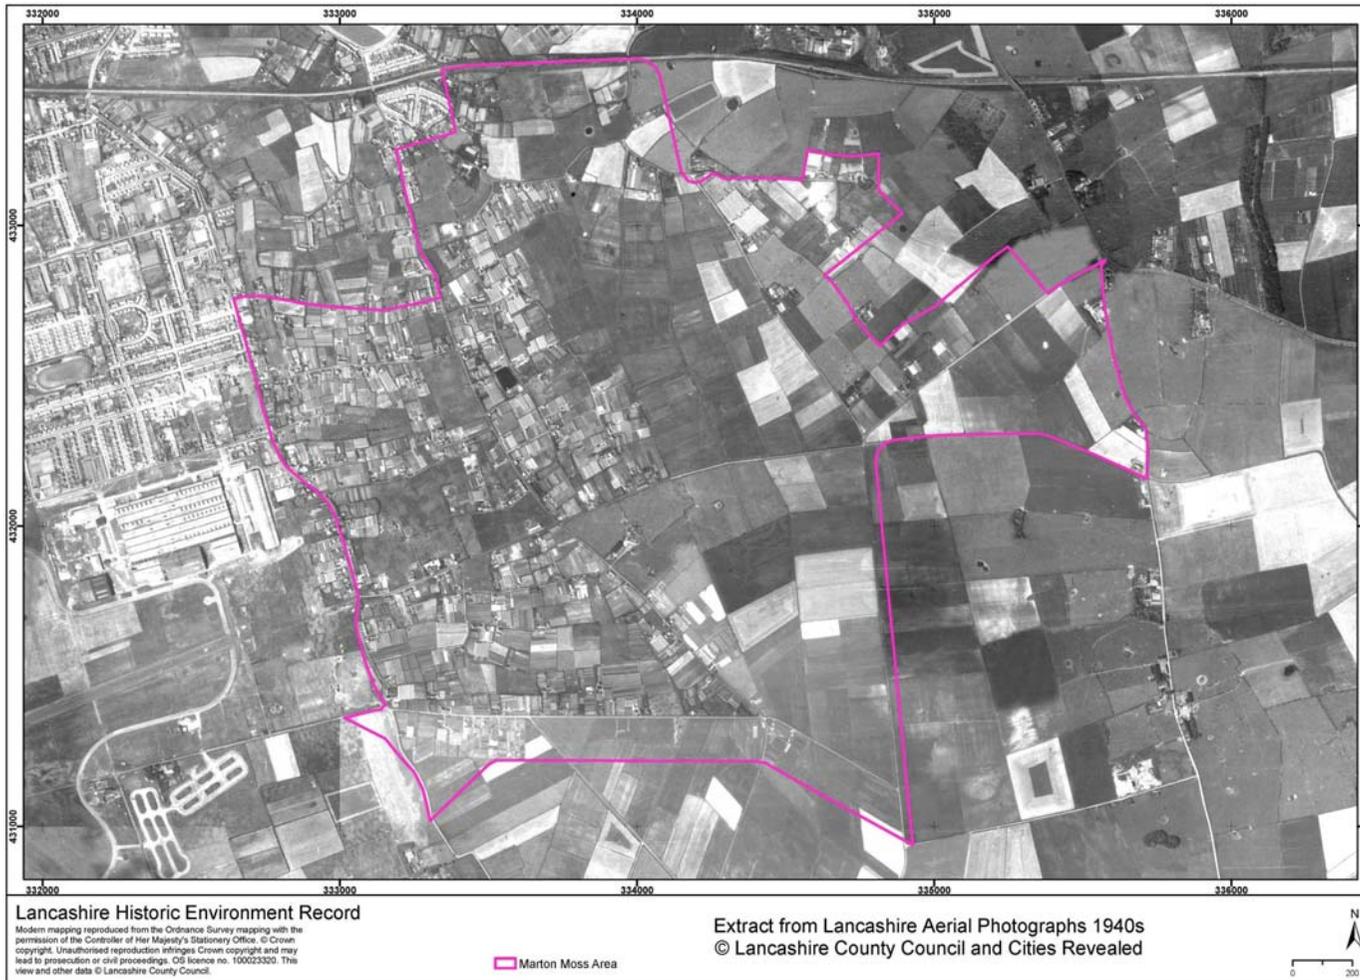
Plate 2. Aerial photograph dating to the 1940s. This shows a clear distinction between character areas, which almost respect administrative boundaries. The airport appears for the first time as does municipal housing between the railway and the northern boundary of the study area

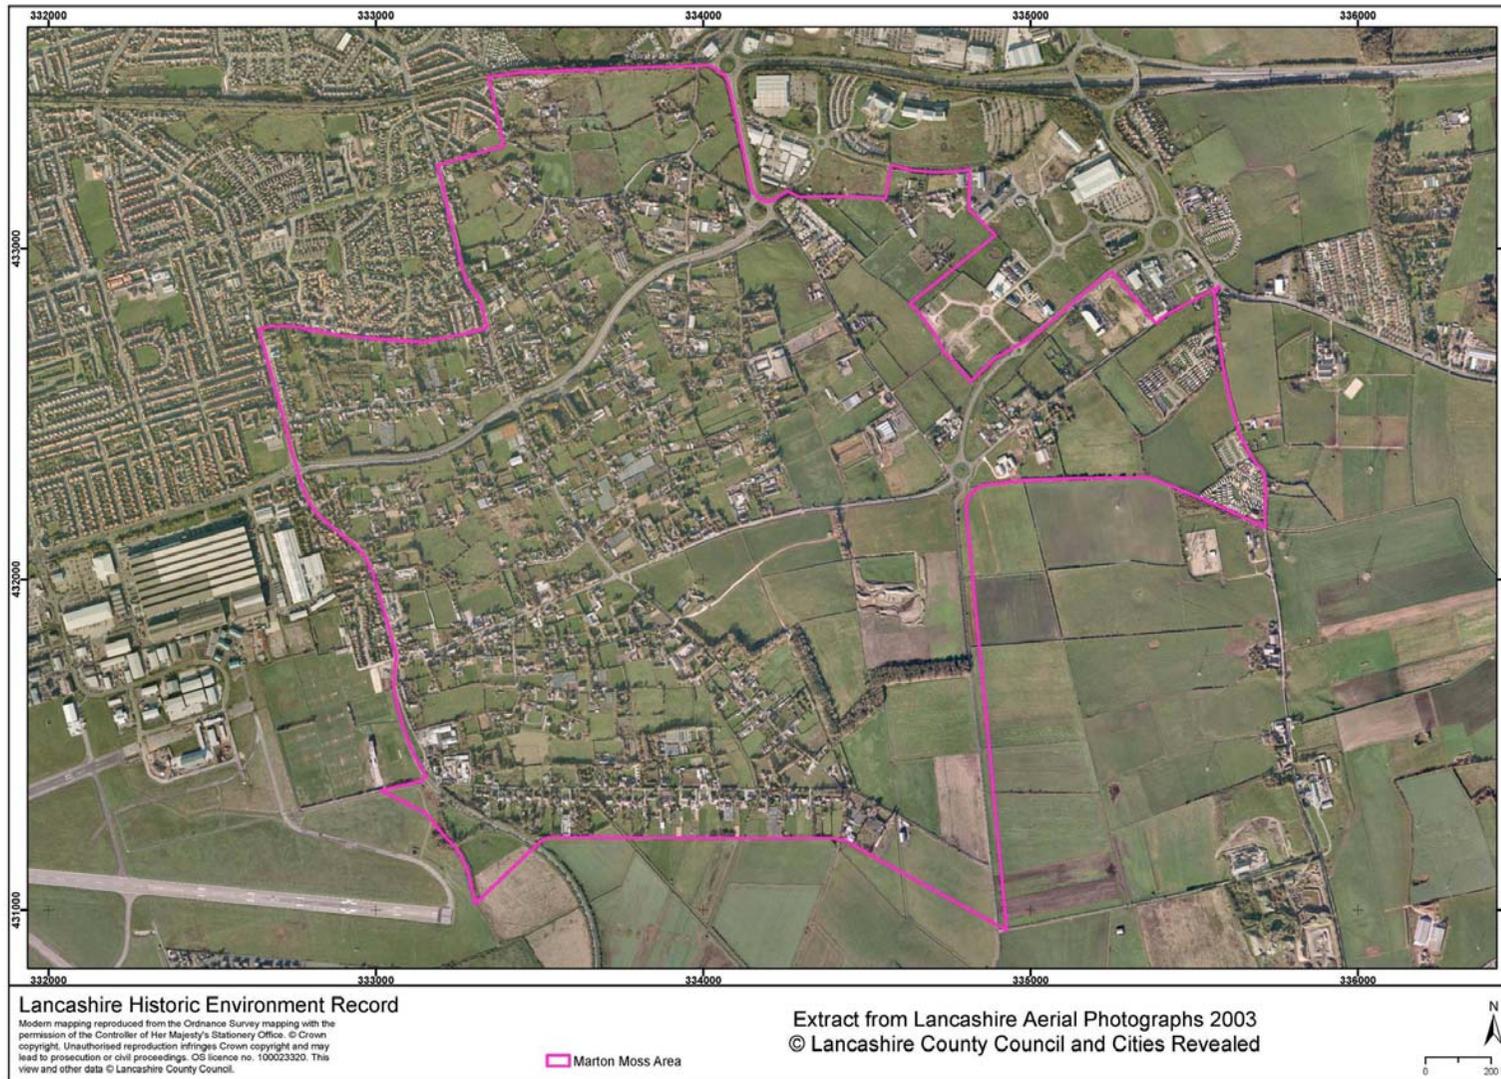
Plate 4. A relatively modern aerial photograph showing the encroachment of new road layouts, industrial estates and government buildings. While they brought much needed employment, they have also introduced a much more modern character to the area and a relatively unattractive introduction to the mosslands. The other modern element in the landscape is the shelter belt which respects the field boundaries which have been rationalised since the 1960s

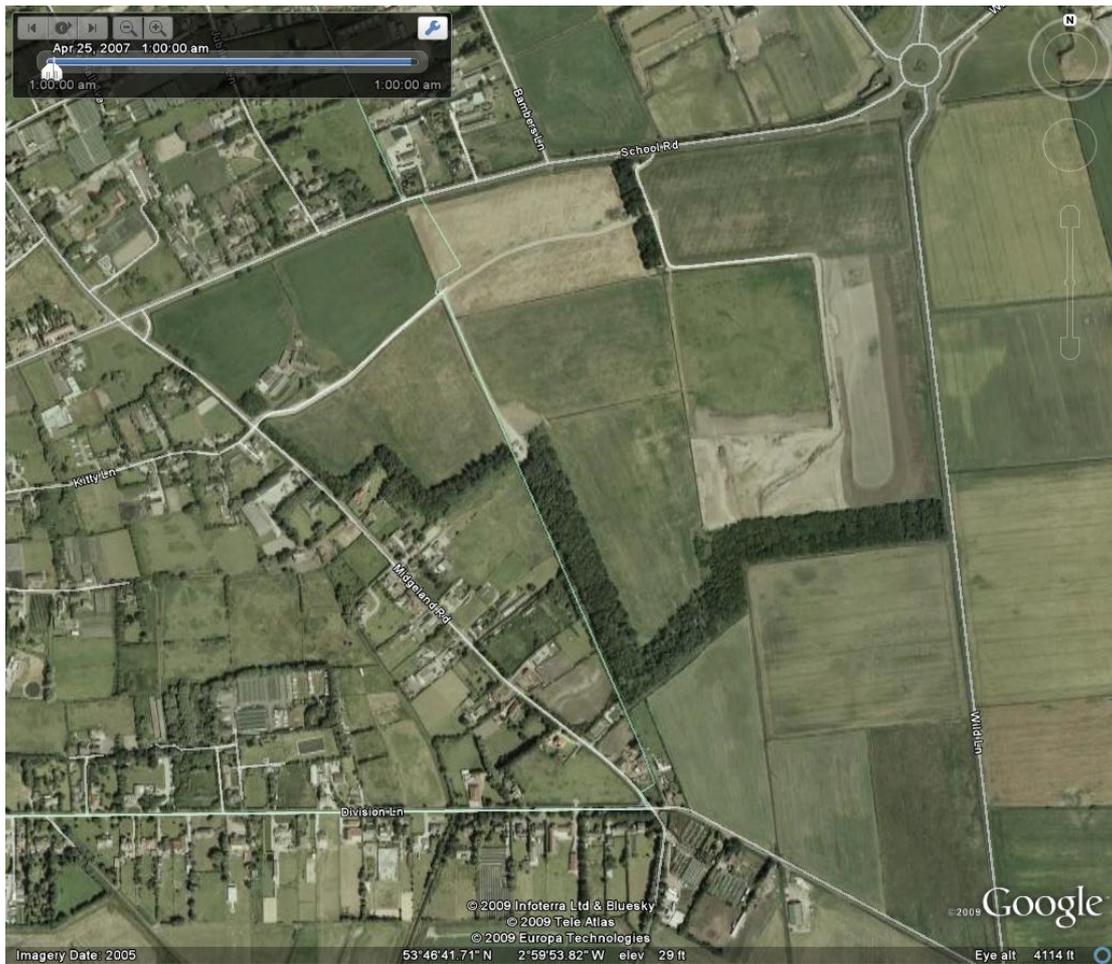
Plate 5. Contrasting field enclosures represent differing histories of ownership – the small plots to the west of Midgeland Road are piecemeal enclosure carried out by numerous different landowners while the larger enclosures to the east represent enclosure imposed by, presumably, a single dominant landowner at a later stage (photo: Google Earth).

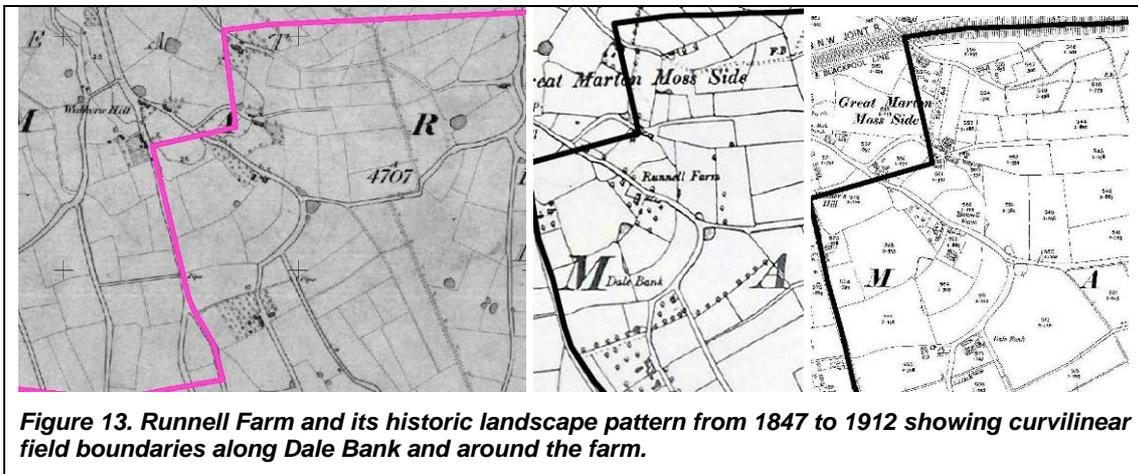
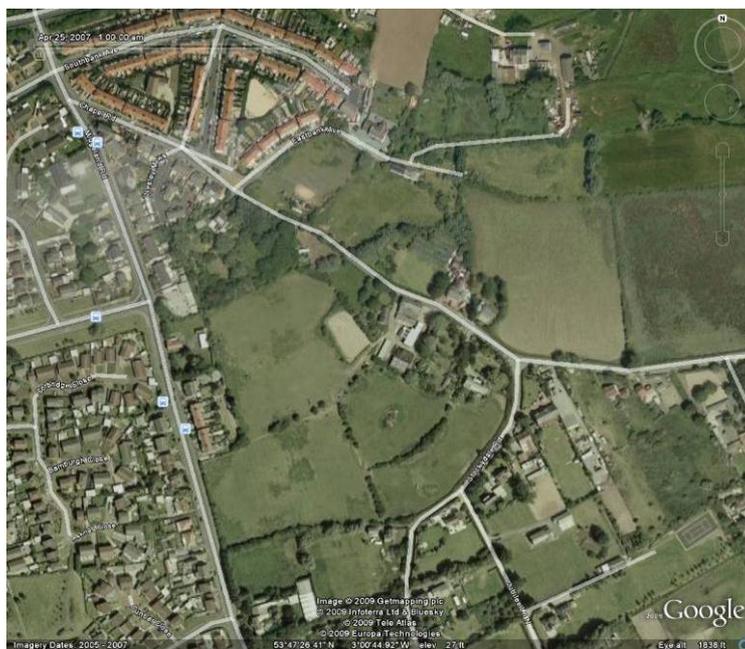
Plate 6. Ancient enclosure field pattern around Runnell Farm. This is small in scale with wavy edges and overall less regular than later enclosure. The boundary of the farm appears to have extended in circular swaithes between the farm and Stockydale Road. Stockydale (Dale Bank in the 1870s) may refer to the road to the doles or turbarly plots

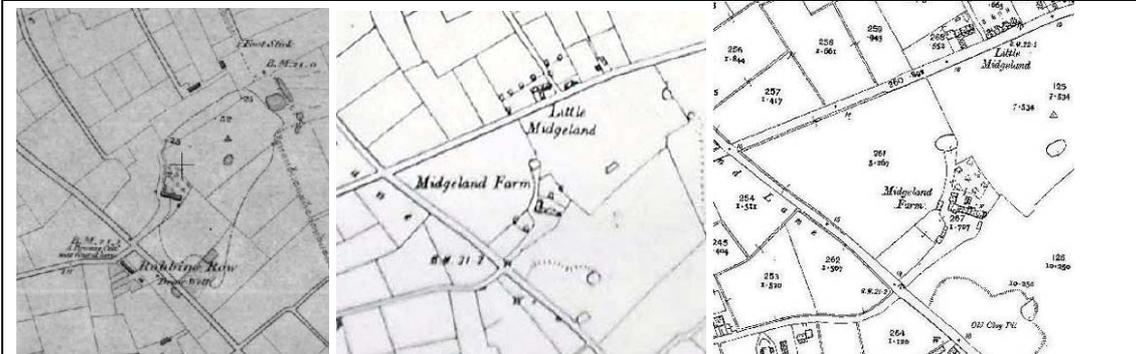
Figure 14. Midgeland Farm from 1841 to 1912. School Lane extends to the north of the farm after 1841 and before 1891 and the row of terraces known as Robbins Row disappears from the mapping at the same time. A clay pit is constructed south of the farm and appears to be active in the late 19th century, but disused by the early 20th. It was presumably used to make bricks for building.

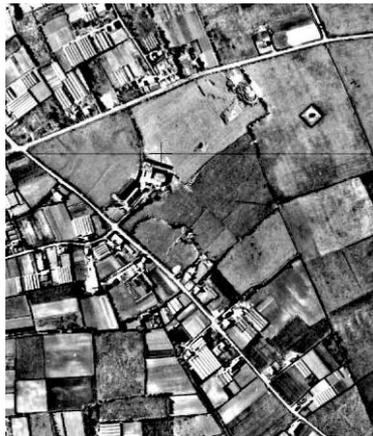
Plate 7. Pre-1840s field boundaries at Midgeland Farm are still identifiable through aerial photography in the 1960s. The old clay pit is now lined with hedging.

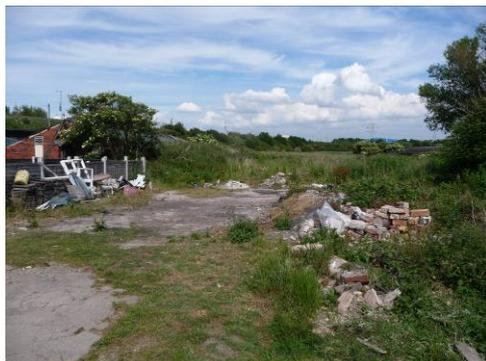
Plate 8. Anciently enclosed field boundaries are well masked at the north end of the study area

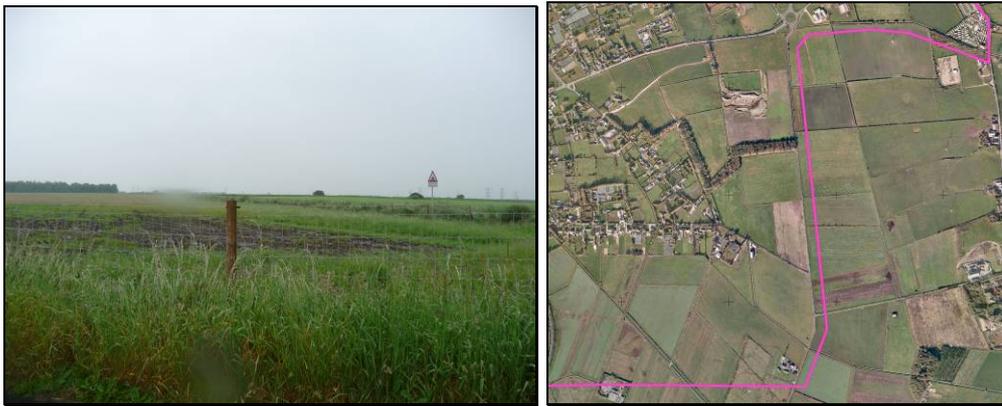
Plate 9. The post medieval enclosed landscape has a more open character due to the use of post and wire fencing and drainage ditches to create boundaries. The shelter belt is out of character with the historic tree cover, but quite common on post medieval enclosed landscape types nationally.

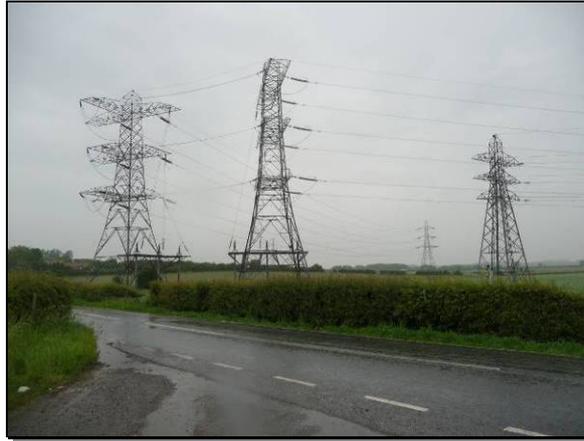
Plate 10. The modern enclosure landscape character has been altered with modern day features such as pylons

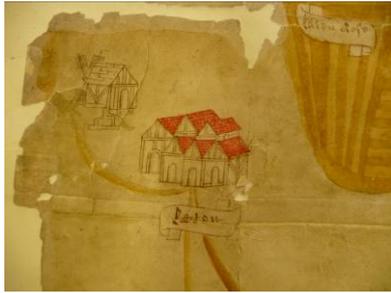
Figure 17. Detail of a map dating to 1700. The houses are depicted as timber framed with red pantiled roofs. There is no evidence that this is how the houses at Marton appeared, but is presumably a symbolic representation only. However the post built windmill is an accurate representation.

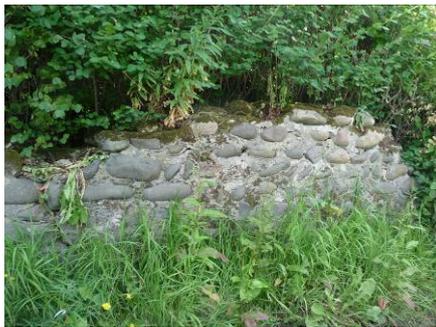
Plate 11. A piece of surviving cobble wall on Chapel Road

only a few examples can now be found in the area peering out from hedgerows or glimpsed from a travelling car (see plate 11). Earlier examples are roughly coursed cobbles bounded with mortar (see plate 11), but later examples tend to be more decorative with rows of colour co-ordinated cobbles often seen in front of cobble cottages. They are also distinctive of the Lytham St Anne's area and the South Shore area of Blackpool.

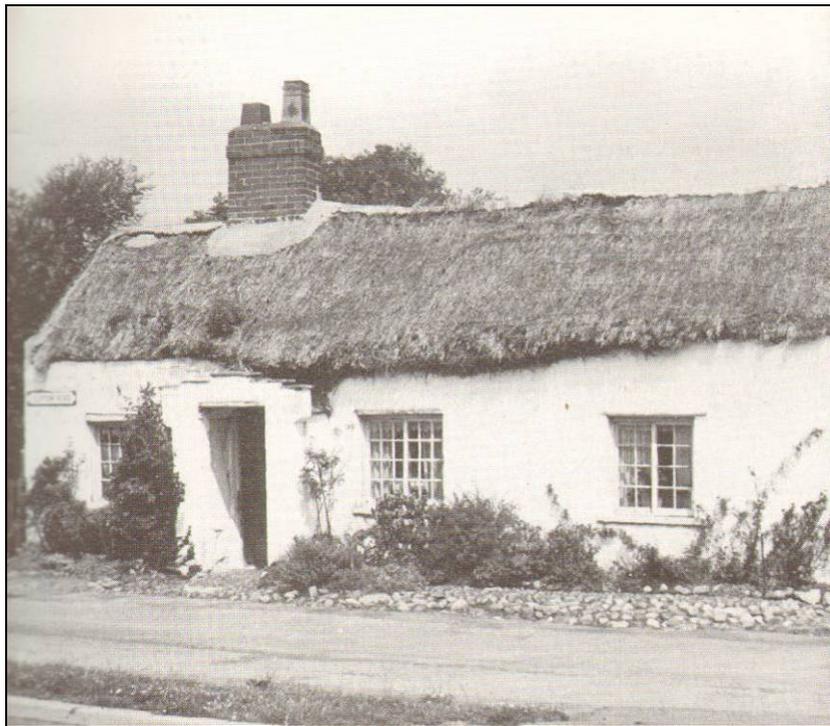
Plate 12. The typical 18th and early 19th century house was the Fylde long house, made of sea cobbles, patched and altered with brick and held together with lime render. Roofing was in thatch and windows were multi-pane Yorkshire sliding sashes. Very few of these survive, although many more may be masked by later modifications, but the low and long cottage style lends itself well to creating a modern vernacular for the area.

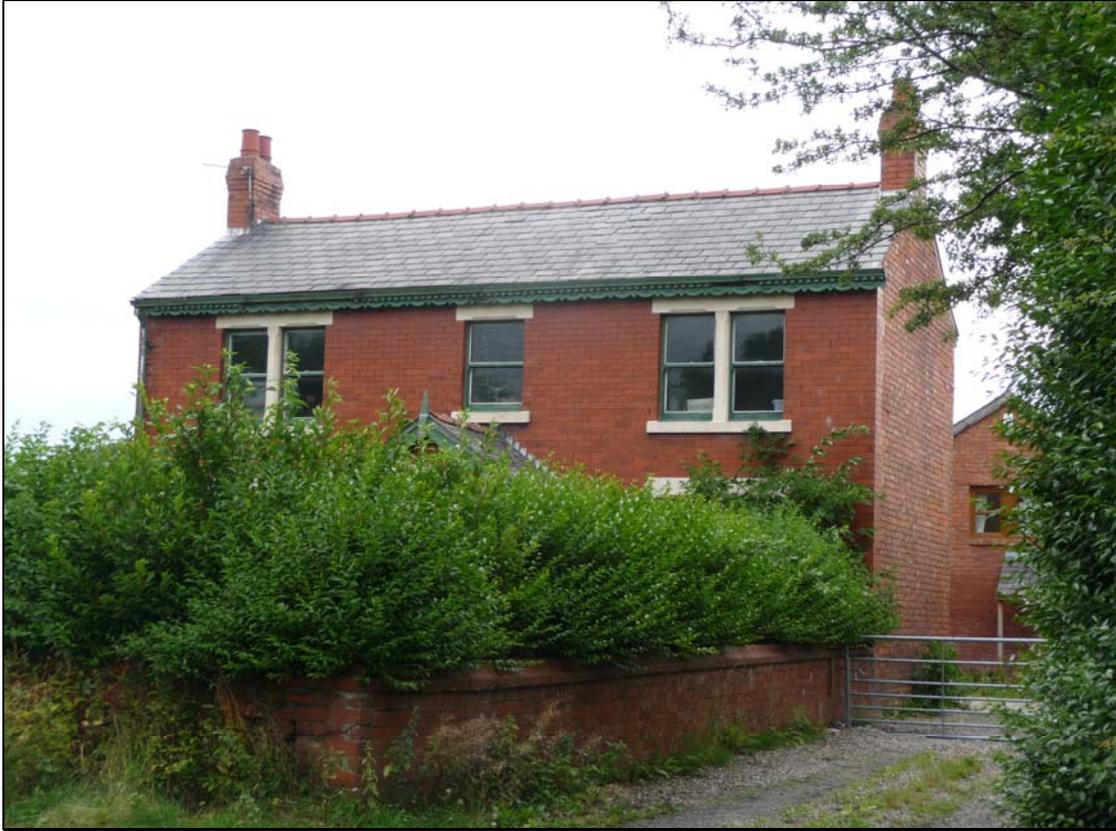
Plate 13. A typical late 19th century detached villa with carhouse behind. This example on Stockydale Road has retained many of its traditional features; a relative rarity in the study area

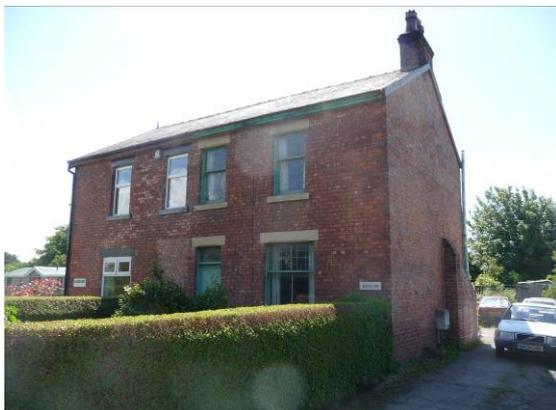
Plate 14. A pair of terraced houses, the one on the right still retains its traditional windows and doors

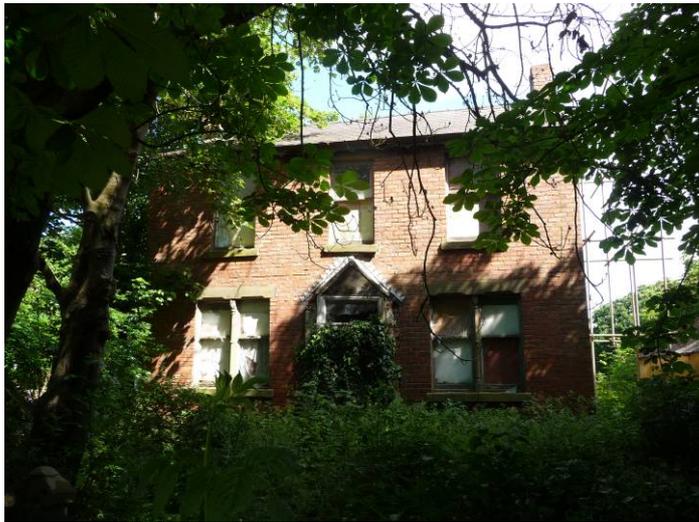
Plate 15. Worthen House today behind Division Lane, built after 1892 to replace a cobble cottage by Mr Boardman

In 1892 Mr Boardman bought his rented cobbled cottage just behind Division Lane from the Clifton Estate and started work on his new brick villa, Worthen

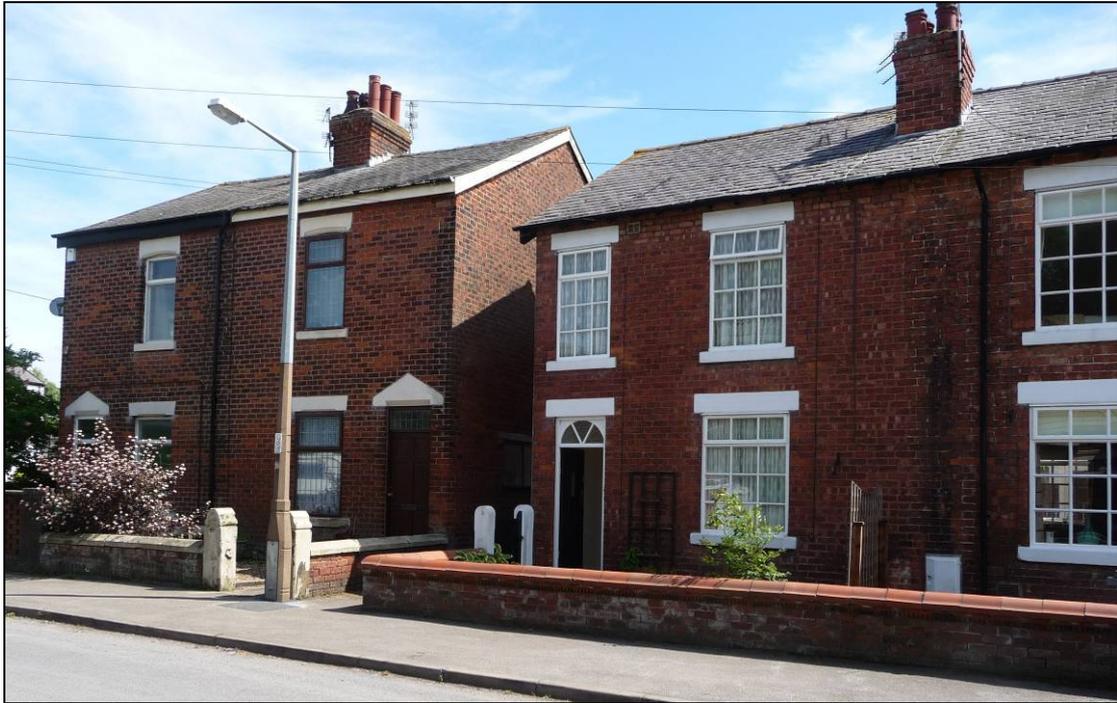
Plate 16. Rows of brick built terraces from the late 19th century, a result of speculative development. The unusual triangular door lintels are also seen at Rosehill Cottage on Chapel Road. Also note the typically Blackpool gatepost in painted stone on the street front and the glazed capstone on the low red brick garden walls – all distinctive to this area.
