The Historic Characterisation of Marton Moss

Report No: 0068/01-09

Archaeo-Environment Ltd
Marian Cottage
Lartington
Barnard Castle
County Durham
DL12 9BP

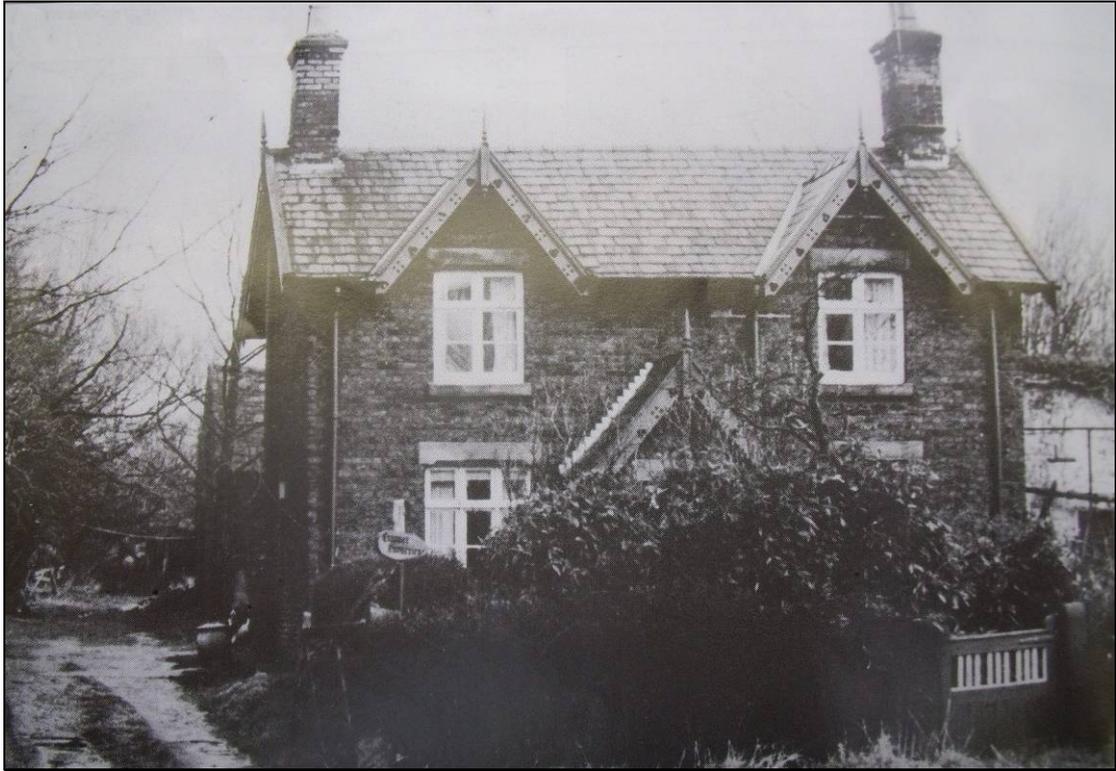
Plate 17. Cropper Road nurseries built in 1872 and now demolished to make way for the Peel Road industrial estate. The use of decorated bargeboards on the side elevations, the dormers and the central porch, plus the pinnacles on each gable and tall chimneys heightened the house to create an airier more spacious cottage than the earlier cobbles cottages.

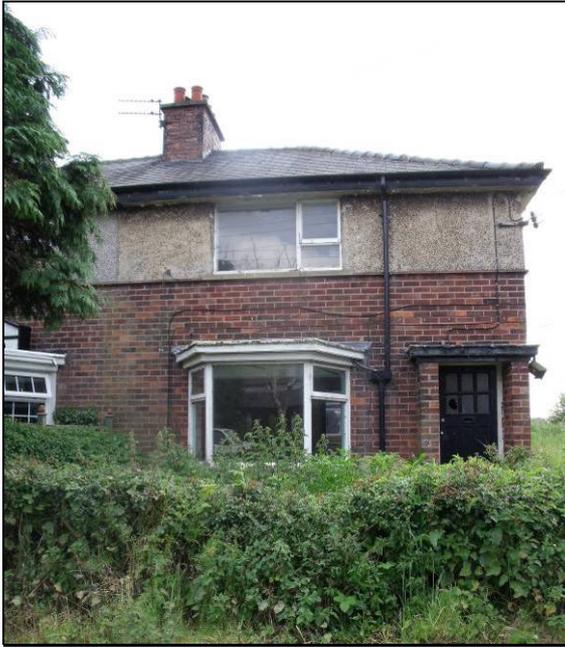
Plate 18. a typically 1930s building in the moss area with a harled top floor and brick ground floor and standard 1930s half glazed door. The windows are later replacements

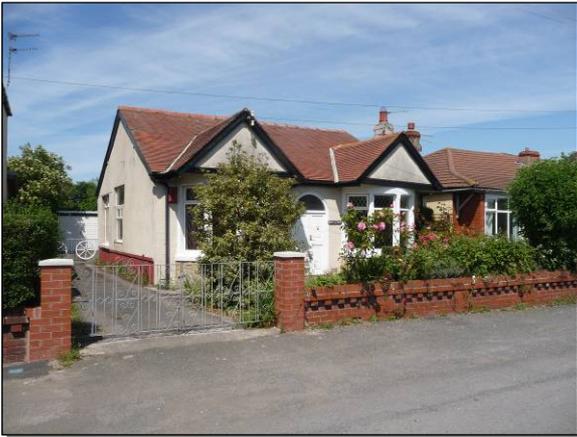
Plate 19. A 1930s bungalow with central doorway and bowed windows. Bargeboarding here is plain and the red brick boundary wall reflects earlier traditions.

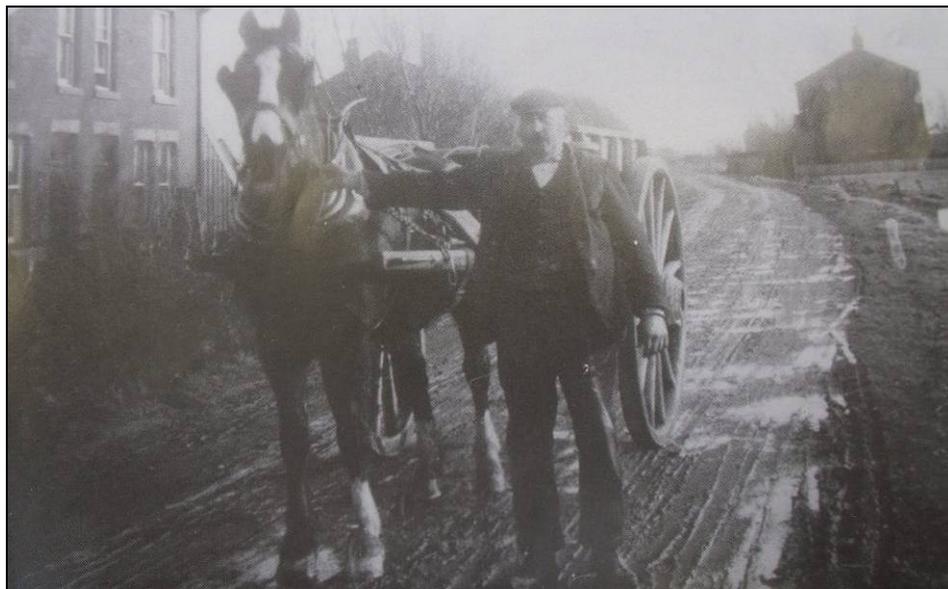
Plate 21. Midgeland Road (Lane as it was) c.1900 facing south. At this time it is still a muddy lane with drainage channel and a very different character to today's busy road.

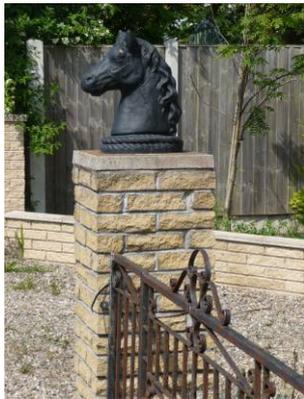
Plate 22. Horse head gateposts dominate in the mossland lanes, although a variety of other designs can be found too including parrots, pigs and acorns.

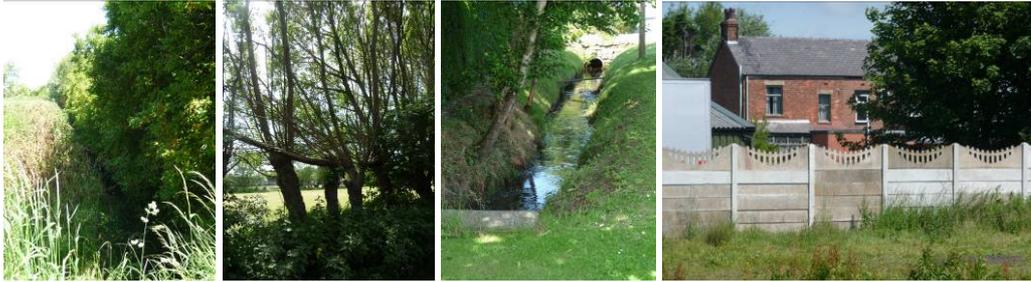
Plate 23. For much of the area, the small plots have water filled ditches as field boundaries around which additional tree and hedge cover has grown, mostly since the 1940s. Where the field plots have been developed, the water filled ditches are retained and become either garden features or streetscape features. Not all fencing is so green, there are a number of wooden fences and around the Sandy Lane and School Road area a number of these concrete fences designed to look like wood

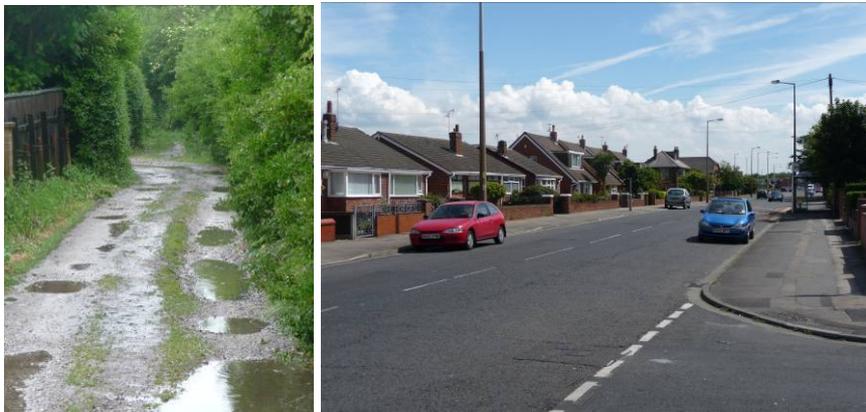
Plate 24. The leafy lanes off Division Lane and Midgeland Road contrast sharply with the more developed urban streets of School Lane and Common Edge Lane

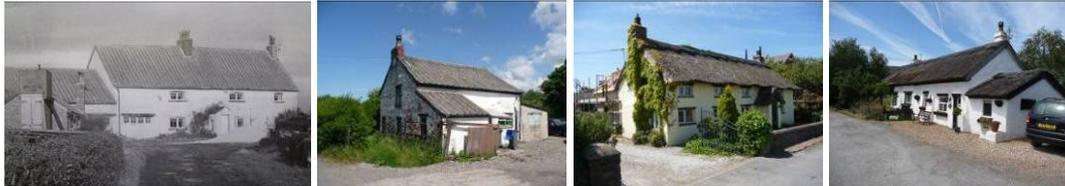
Plate 26. Early cobbled houses from left: Midgeland Farm, The Pod (?), Worthington Road, Fisher's Lane (LB).

Midgeland Farm is also within this character area and is now in poor condition. Remnants of its thatch can be seen, as can its tiny Yorkshire sliding sashes below the eaves, although other windows and doors are boarded up. The site is currently locked away from the public's gaze, but must be considered as a potential listed building with its conservation and recording a priority. Finally, the farmhouse at Pods (as it was known in the late 19th century, named after a Scotsman Jack o' the Pod, a gamekeeper in the mid 19th century) was demolished in the 1920s, but today a building remains upon the site which might be brick encased cobbling. The thatched roof has gone, but has been replaced with the equally ubiquitous corrugated tin roof and at first floor level there is the remains of a Yorkshire (?) sliding sash window. Other windows are mid 20th century replacements. It is in poor condition, and has recently been granted planning permission to be demolished.

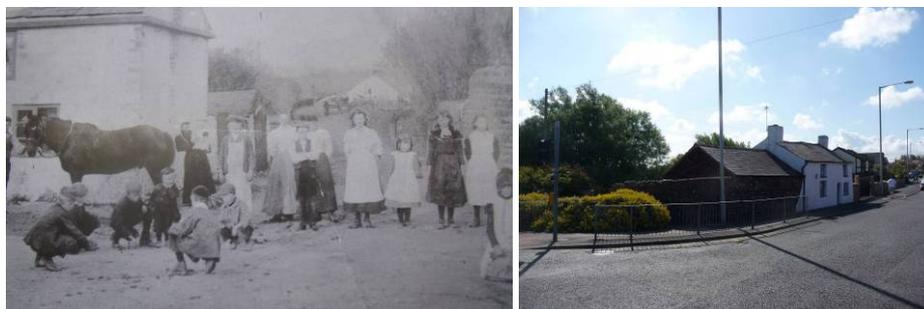
Plate 27. Blowing Sands c.1900. The cobble wall on the right of the picture remains today, but otherwise the area has changed beyond recognition

The earliest buildings within this character area are cobbled cottages dating to the 18th century (or before). The most prominent is the listed building at Blowing Sands where it sits on a busy junction, far removed from its original setting. It still has a stretch of cobbled walling adjacent to it. Like many of

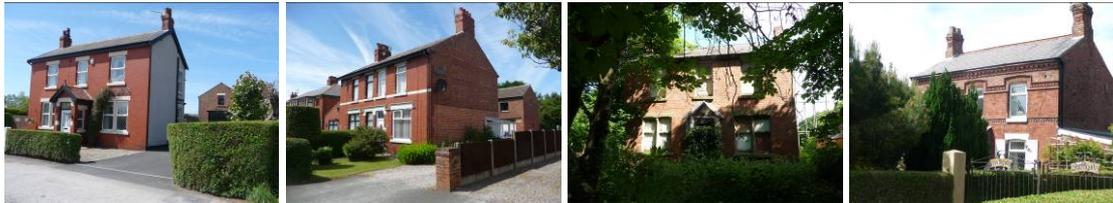
Plate 29. Late Victorian houses all brick built with stone detailing. Southgate at the end is unusual in being highly ornate. From left, Kitty Lane, Sandy Lane/Moss House Road, Division Lane and Bennetts Lane

The next major phase of development in this character area introduced Victorian styles of architecture. Initially this took the form of brick built detached houses for the tenants or owners of nurseries complete with brick built cart shed to the rear, garden and boundary walls. Most examples are relatively plain with stone finishings to windows and doors, although decorated bargeboarding makes a consistent appearance throughout the character area on even the most modest houses, as does terracotta ridge tiles. The high rate of survival of these features is a particularly distinctive feature of this character area. The majority have lost their traditional windows and doors, but most retain their slate roofs, brick chimneys and gateposts to the front garden. One or two examples stand out because of their higher quality of ornamentation or higher status; other because they have been modernised beyond all recognition. This style of Victorian house went on to inspire later development from the early 20th century including arts and crafts styles, 1930s and 50s villas and more recent developments in brick with stone finishings and ornamentation (see below).

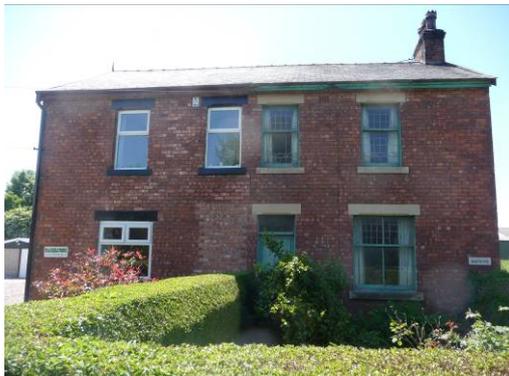
Plate 30. Wayside on the right has retained its original sash windows with lead decoration, its four panelled door and overlight, but Hazeldene next door has not fared so well

This area has the highest density of 18th and 19th century buildings in the study area, but they are threatened by a gradual loss of traditional features such as windows and doors. Only one terraced house was identified which had retained these traditional features (Wayside on Kitty Lane, see plate 30). This contrasts with the survival of decorated bargeboarding which has survived well throughout the study area and is particularly characteristic of it. There have also been more extreme examples of modernisation where the original house is barely recognisable.

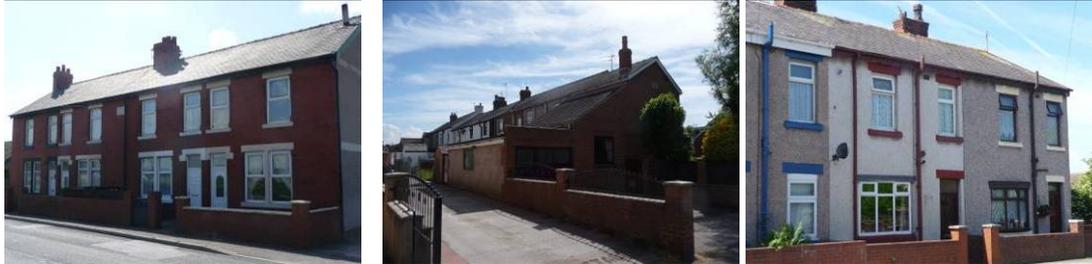
Plate 31. Terraces possibly the result of speculative development. From left: Primrose cottages on School Road built in 1899, Hall's Cottages built in 1897⁸ on Stockydale Road and 342-6 Midgeland Road, part of a longer terrace.

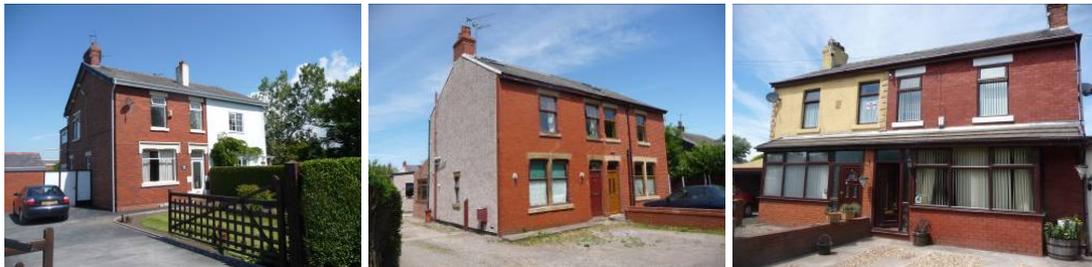
Plate 32. Twin terraces: an early form of development on the mosslands. From left: Manor House on Kitty Lane with ornate stone lintels, but loss of traditional windows and door has fared better than its neighbour; Ecclesgate Road, with loss of traditional windows and front garden; Fishers Lane with modern porch to the front, replacement modern windows and loss of front garden

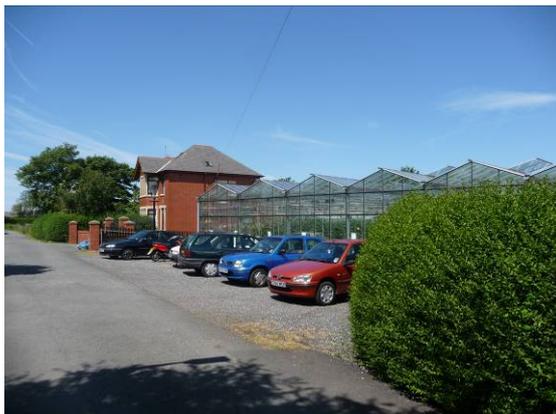
Plate 33. Typical glass house layout across a plot with red brick dwelling adjacent

The most common building type in the area is probably the glass house, associated with the many nursery businesses. These typically occur in rows filling up one plot and have a house adjacent which originally housed the main nurseryman. Due to the decline in businesses, a number are now derelict but they still occur in sufficiently large numbers to contribute towards the character of the area. Many other have been demolished and turned into horse related

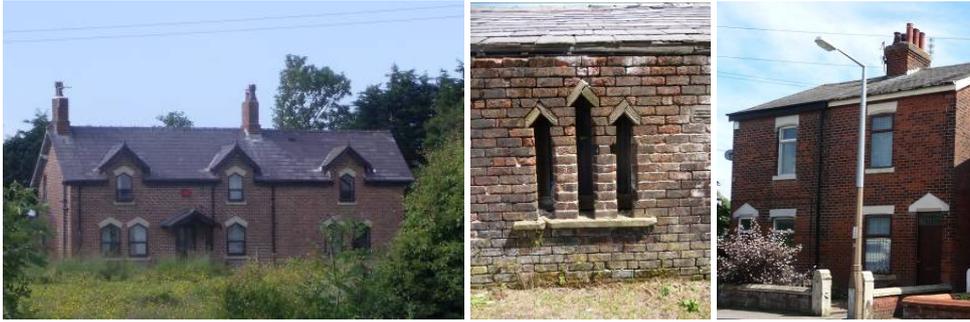
Plate 34. Triangular lintels make a brief but distinctive appearance in this character area; Rosehill Cottage on the right is only just inside character area 2.

with two dormer windows in the roof and a central porch. The dormers and porch were usually decorated with ornate bargeboarding. Very few of these survive in this area. In the north end of the character area there is an unusual lintel design which appears to be distinctive, but not common. These are triangular lintels found at Stockydale Road, Chapel Road and on a barn on Moss House Road.

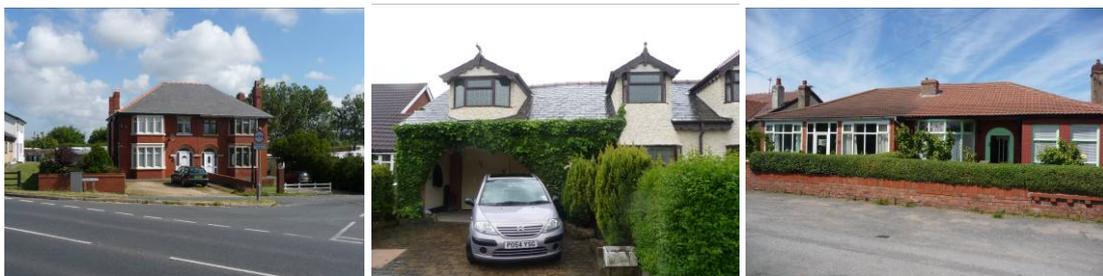
Plate 35. 20th century styles started with relatively modest styles including villas with design features from early England, in this case on the corner of Division Lane and Queensway, stone mullions and lead diamond glazed windows. Bungalows were built from the 1930s some with ornate bargeboarding and finials, this one (centre) at Midgeland Road, some with more traditional features, this one on Moss House Road (right). Most have suffered from alterations ranging from the loss of traditional window styles to the more radical which masks the original design (see right picture, left hand house)

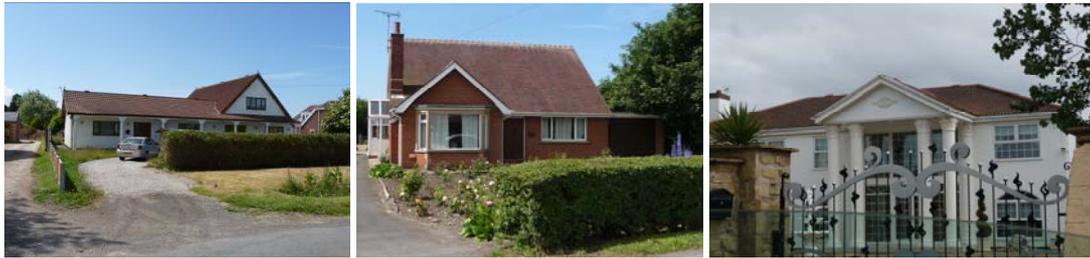
Plate 36. Some of the individual styles of the mid to late 20th century

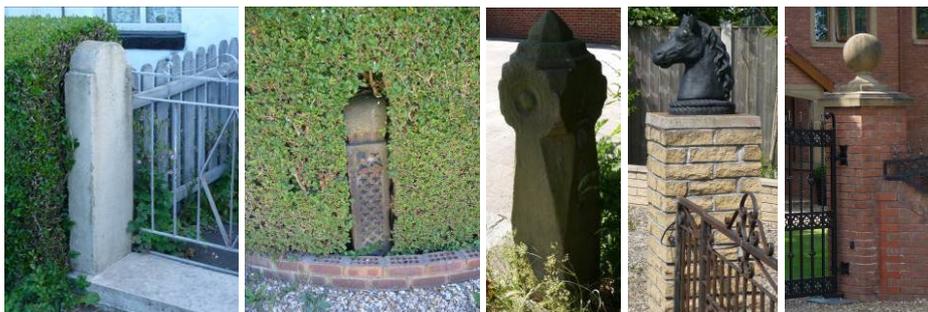
Plate 38. A typical selection of gateposts from this character area

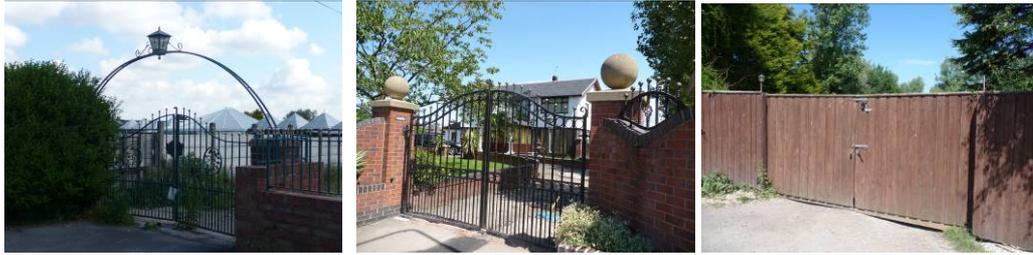
Plate 39. Many of the boundary walls around private dwellings in this character area are designed to display wealth or protect privacy

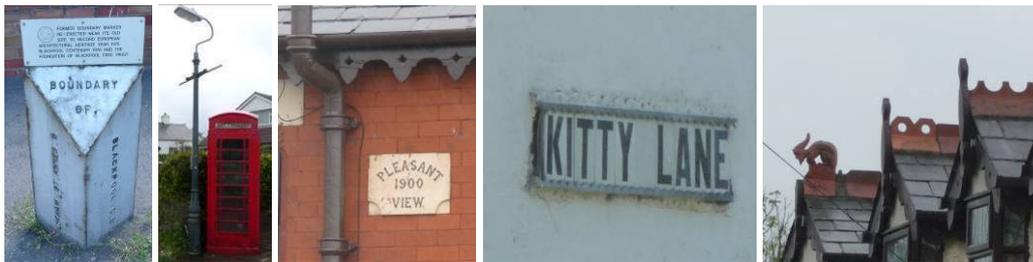
Plate 40. Small details which are either a link to the past such as the boundary stone, older ornate style of lampposts, K6 telephone boxes, decorated bargeboards, datestones and street names or just fun (see the gargoyle on the kneeler) contribute towards a sense of character.

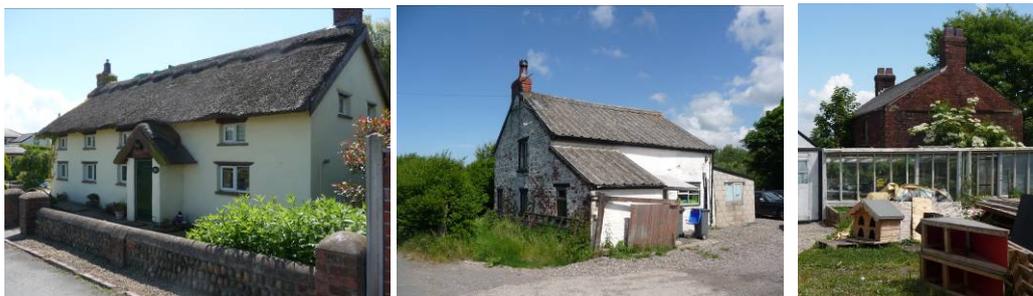
Plate 41. Buildings which merit closer inspection and possible inclusion on a local list: Worthington Road (modernised); The Pod on Midgeland Road; 232 on Common Edge Road

benefit closer inspection and possible listing, as would the thatched cottage on Worthington Road. Midgeland Farm is a well known cobbled construction and may merit listing. Its repair and conservation should be seen as a high priority as it is one of the key historic buildings in the area. Another historic building is also falling into disrepair just off Division Lane. Worther House was a fine 19th century villa complete with carhouse, laundry and coal store and several acres of nursery. It has been uninhabited for many years and requires urgent remedial repair which should include the retention of traditional fixtures and fittings. It may be possible to fund this through enabling development nearby.

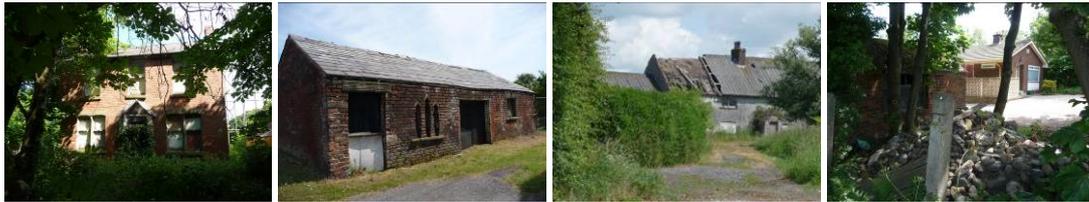
Plate 42. Buildings under threat: Worther House off Division Lane (left) the barn on Moss House Road, Midgeland Farm and an ominous pile of cobbles next to a new house on Ecclesgate Lane and a brick cart shed – was this one that got away?

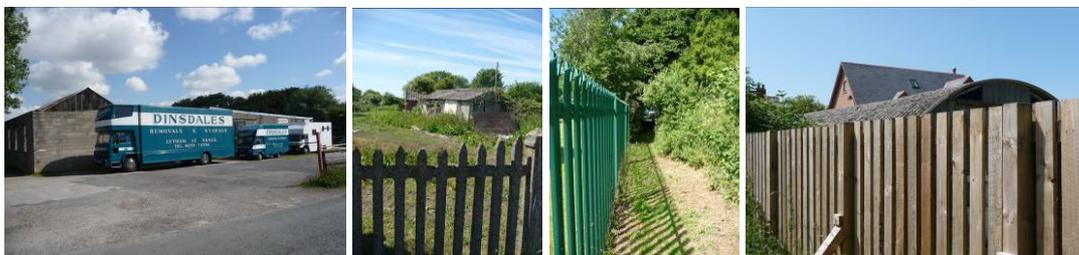
The character area still has a number of eyesores. Next to Worther House, a former nursery has passed through a series of owners and uses resulting in a derelict and unsightly group of buildings which are a poor introduction into the road. Similar areas of waste and neglect are to be found on a number of plots, but in some cases this could be considered to be part of the character of any rural area and future development should not necessarily create a manicured appearance more suited to a modern housing estate. A balance needs to be obtained between charming rural neglect and obvious eyesore. Much can be done by giving greater consideration to boundary treatment. Hedges are the traditional form and also provide opportunities to create wildlife corridors. Boundaries such as barbed wire, tall solid fences, artificial stone and cladding contribute little to the area.

Plate 43. Some plots have been through a number of changing land uses resulting in badly maintained buildings of poor quality; these plots could benefit from a change of use. Other plots in some cases are moving from gentle neglect to eyesore. However much could be done to retain the rural charm of the area if more consideration was give to appropriate boundary treatments.

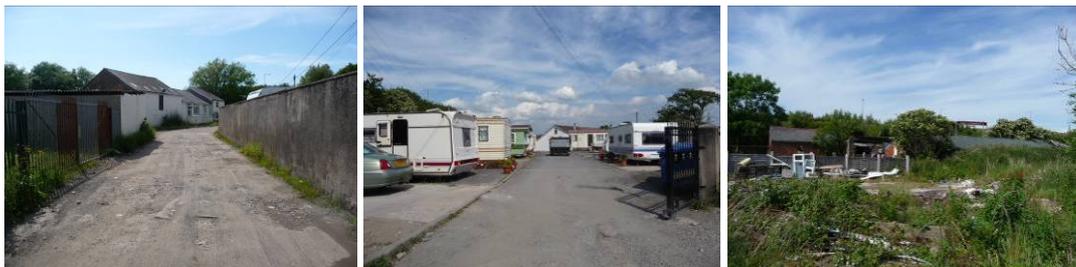
Plate 44. Unsympathetic boundary treatment, poor landscaping and a lack of maintenance have introduced a feeling of neglect around Whalley and Lilac Farms

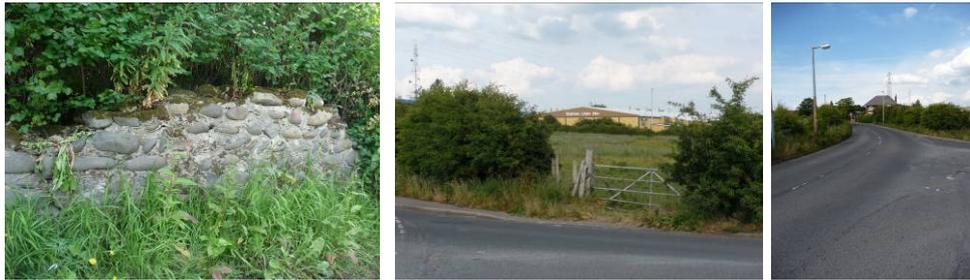
Plate 45. A relict piece of cobbled walling along Chapel Road (left), as the views move eastwards they become more open and look towards a modern industrialised landscape (centre and right)

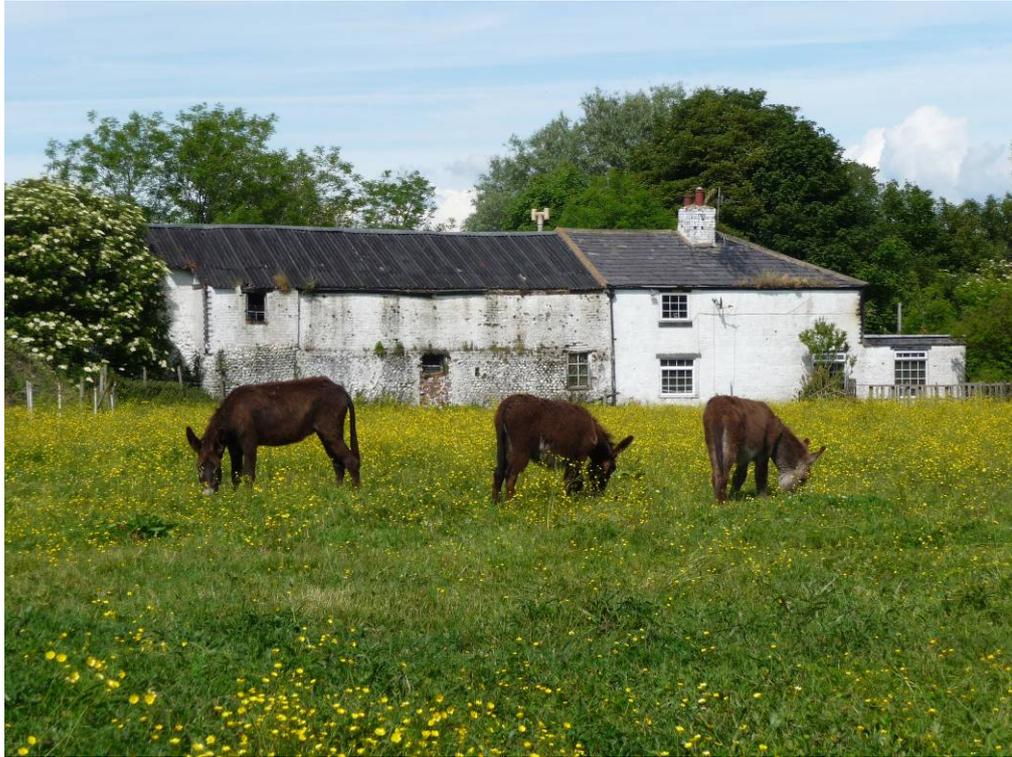
There is a curious mixture of buildings in this character area. There are more agricultural buildings present than elsewhere on the mosslands, presumably due to a longer farming history. However with the exception of Runnells Farm, the historic interest of some of the buildings is well-disguised. Runnells Farm has been on maps since at least 1839 (Tithe map) and could conceivably be one of the farms shown on the 1700 map (figure 4). The field system around it appears to be pre-18th century, possibly 16th century. While the house has been modernised, effectively masking evidence of an earlier building, the outbuildings have been subject to less treatment and on the ground floor the building materials may be cobble. The outbuilding roof is of corrugated iron, a popular replacement for thatch. This building merits further examination and possible inclusion on the local list or as a potential listed building. The quality of the historic building stock improves towards Stockydale Road with some thatch and a rare Victorian detached house with traditional features (see Local List recommendations).

Plate 46. Runnell's Farm showing signs of being a possible cobbled building and set within an anciently enclosed landscape

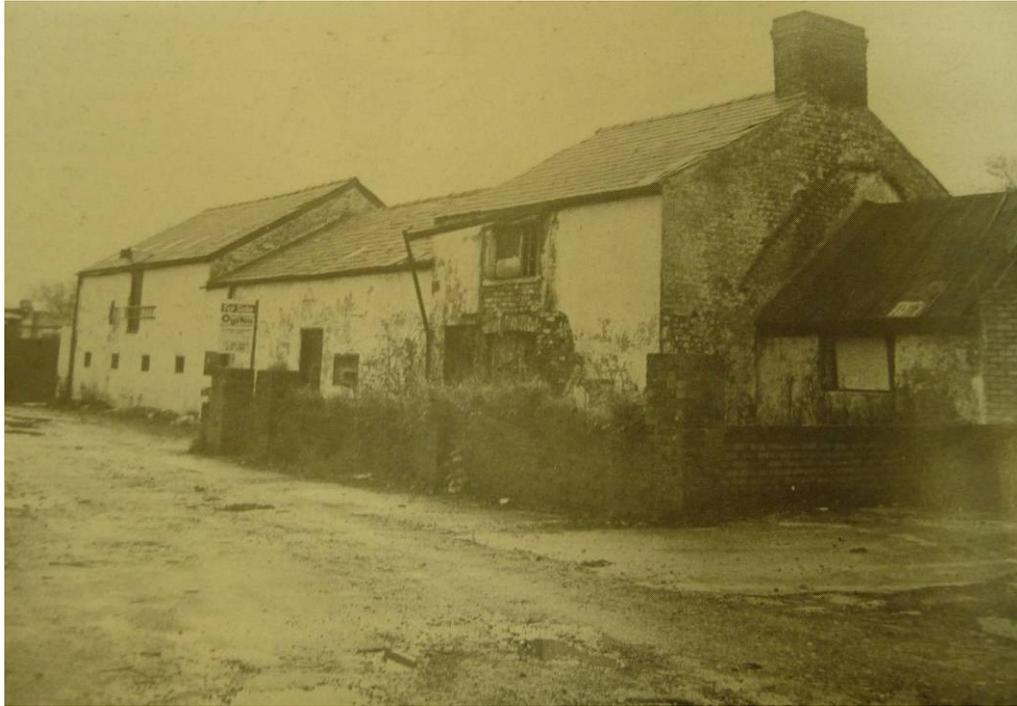
Other farms in the area include Whalley Farm and Lilac Farm. Once again these properties have been over-restored, thus masking evidence of anything of historic interest. Their concrete render may create problems with damp and they sit within an uninspiring streetscape and landscape with a large number of eyesores present. However Whalley Farm appears to have been a cobbled building which was subsequently encased in brick (Monks 1986, 26). It has since been unsympathetically modernised with picture windows, plastic door and concrete render, all of which are reversible. Lilac Farm is surrounded by building debris and rubbish which detracts considerably from the building. It sits behind a willow tree and concrete brick fencing which combined with the pebble dashed coating, does much to mask the fact that this is probably quite a fine building. The porch proudly carries the name of the farm above the doorway. Another curious building within the farmyard area is a wooden and brick structure which appears to be used for storage but which may be a left over from when the Yeadon Way was a railway. At least two other brick buildings in this area may have similar origins.

Plate 47. Whalley Farm Before and....

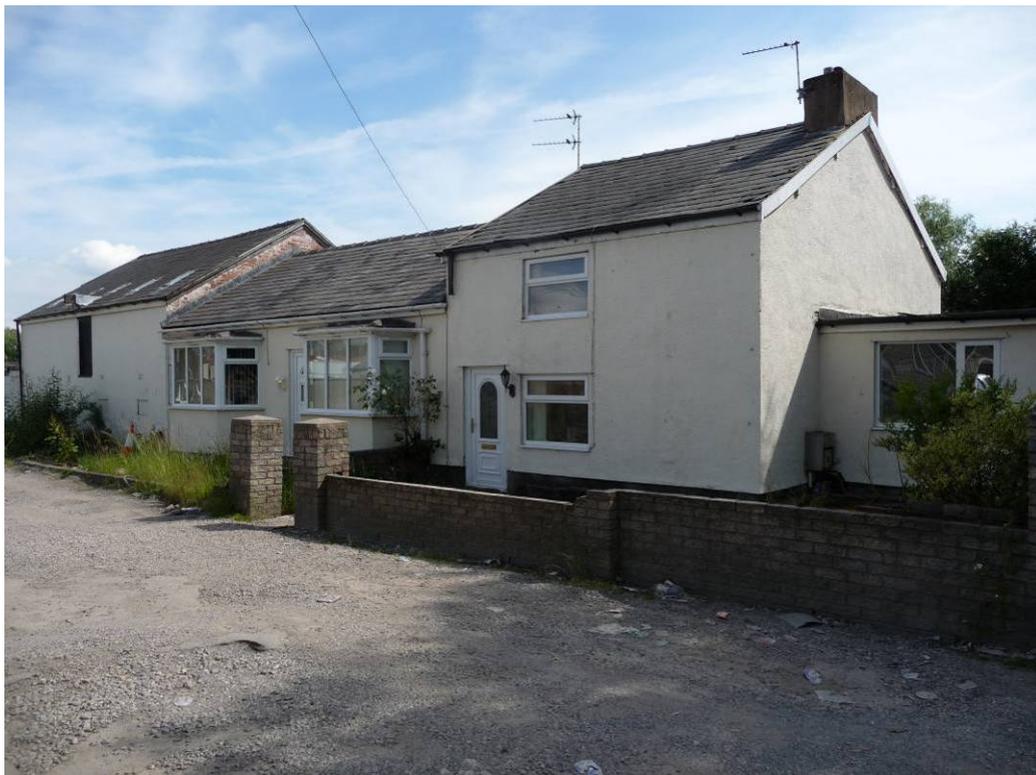
Plate 48. After

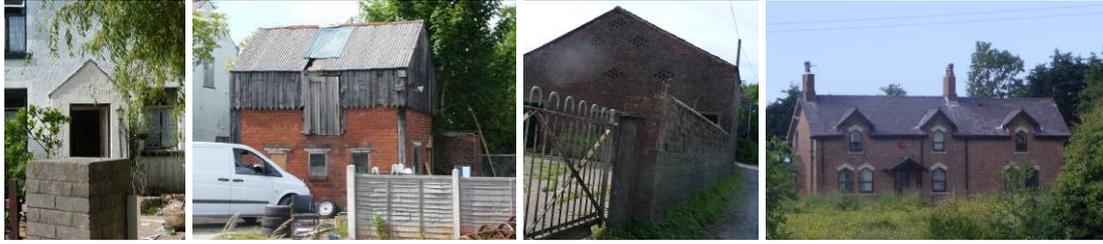
Plate 49. A glimpse of Lilac Farm through the willow trees (left) and the adjacent former railway building (?); 19th century farm buildings along Chapel Road combined with old cobble walls add historic interest, while Rosehill Cottage is one of the few to represent the Victorian cottage (now extended and modernised) with dormer windows and bargeboarding and the typical brick and stone mix. The eye catching window lintels are unusual and reflect the shape of the dormers. Similar window lintels can be seen on Moss House Road and Stockydale Road

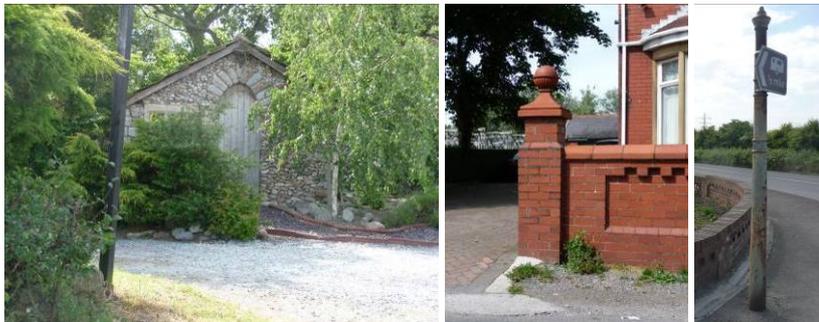
Plate 50. New cobbled buildings, farm buildings, decorated finishings to properties along Chapel Road and a reused fingerpost on Cropper Road (just inside character area 1) offer some features of interest, but the overall character of the area is one of neglect, possibly made worse or caused by the proximity of the modern Yeadon Way and growing industrial estates.

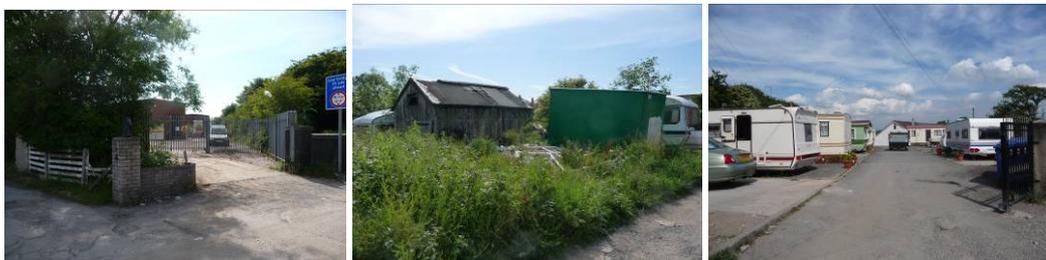
Land between Whaley Farm, Lilac Farm and Yeadon Way has deteriorated and has become an eyesore. The proximity of caravan parks with poor landscaping, badly-modernised historic buildings and poor boundary treatment do little to enhance the area.

Plate 51. Neglect, dumping and poor landscaping do much to detract from this character area which has the historic infrastructure in the form of ancient enclosures and historic buildings to have much more historic character

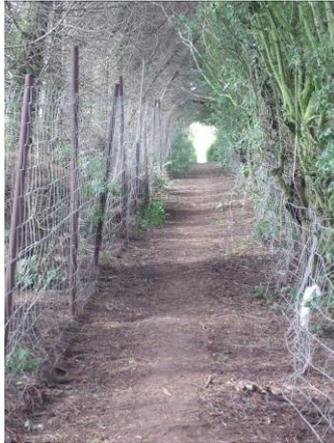
Plate 53. A secluded right of way near Old House Farm with derelict glasshouses adjacent

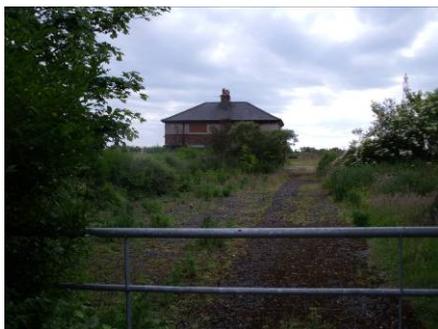
Plate 55. One of two neglected 1930s buildings along Old House Lane

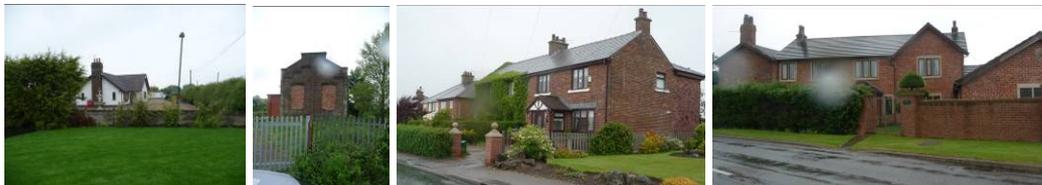
Plate 56. *The majority of buildings use the same red brick in varying shades within this character area, but render is also used to a lesser extent, but does not always fit into the existing character. The scale of buildings is relatively modest with farm buildings at Pipers Height (right) and Old House Lane being the largest.*

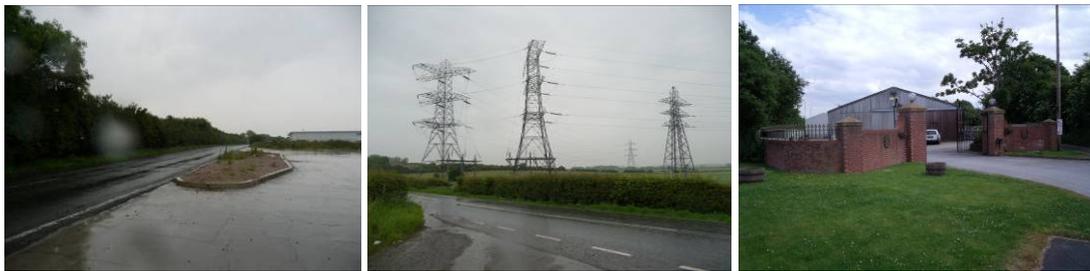
This character area is suffering from encroachment of large scale modern industrial buildings and a busy road network which places it in a transitional zone between rural tranquillity and light industry. Even where buildings fulfil a rural function, they are increasingly of a scale more associated with retail and industrial estates leading to a change in character. As a consequence of the increasingly busy road network it is an area where the car is starting to dominate at the expense of the pedestrian/cyclist/horse. Careful thought needs to be given to how much further this erosion of character should dominate and to what extent the quiet lanes with hedges remain.

Plate 58. Poor landscaping at the periphery of the character area, dense pylon cover and the encroachment of large scale modern buildings with suburban boundaries are moving this from a semi-rural area to a light industrial urban fringe

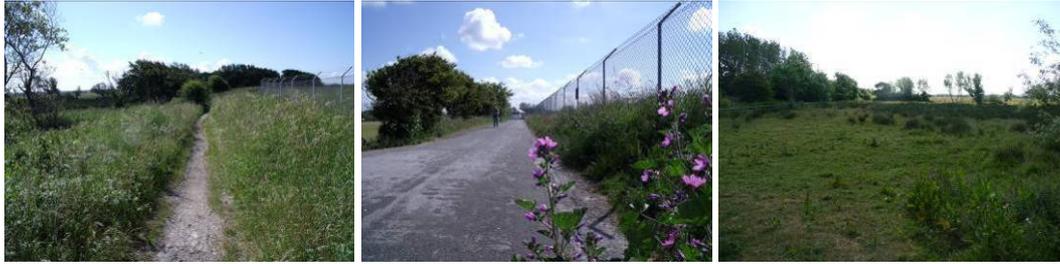
Plate 59. *The former Moss Edge Lane is now a footpath and bridleway (left) and another lane forms the northern boundary (centre), but both have intrusive security fencing. The paddock sits at a lower level than the new road and the fields from the west suggesting that it has gone through some shrinkage through peat extraction and drainage*

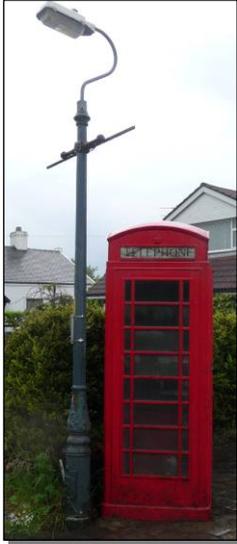
Plate 60. K6 telephone box on Midgeland Road

There is at least one K6 type telephone kiosk in the area on Midgeland Road (NGR SD34127 31654). This is one of a series designed in 1935 by Sir Giles Gilbert Scott and made by various contractors in cast iron with a square kiosk and domed roof decorated with unperforated crowns to the top panels and margin glazing to windows and door. These are often listed in other parts of the country and county and for consistencies sake should be added to the list of historic buildings of architectural of historic interest for Lancashire, as grade II buildings. Another one nearby is no longer in its original location and is therefore not recommended for listing (outside Rose Villa roughly at SD 3409 3174).

Lamppost on Midgeland Road NGR SD34127 31654 K6 telephone kiosk – see section on proposed listed buildings	Dates to first half of the 20 th century (with more recent lamp?) – ornate base. Examples are usually removed and replaced as part of revised lighting schemes and is therefore under threat.

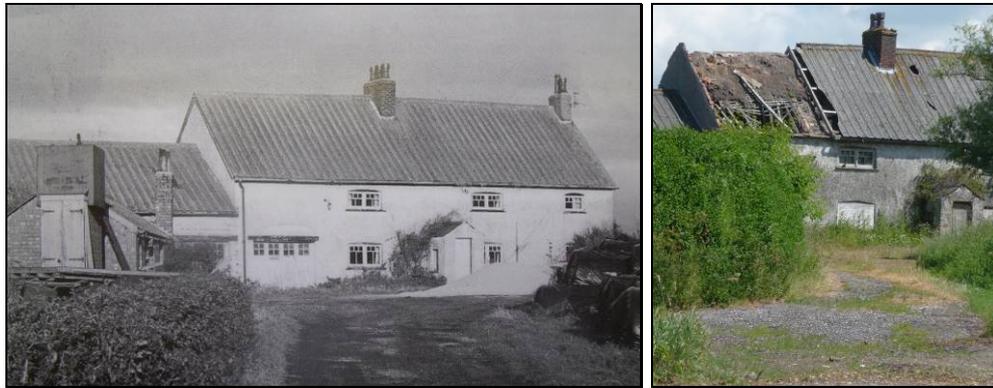
Plate 61. Midgeland Farm in 1985 (left) and in 2009 (right). The corrugated roofing was obviously placed over existing thatching. There has been considerable deterioration while in County Council ownership

buildings which have survived, but were recently granted planning permission to be demolished. At Midgeland Farm the thatch was left in situ and the corrugated iron placed over the top (see local list recommendations). It is likely that higher status buildings were roofed in stone slate and once the railway made the importation of building materials easier from the mid 19th century, a mixture of Cumbrian and Welsh slate was used.

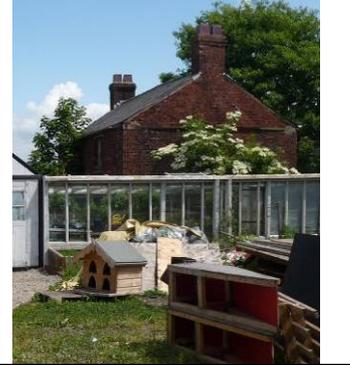
<p>232 Common Edge Road NGR ?SD 32972 32097?</p>	<p>Selected on the basis of a distant view only of the side elevation, but appears to be a Victorian cottage which might retain traditional features</p>

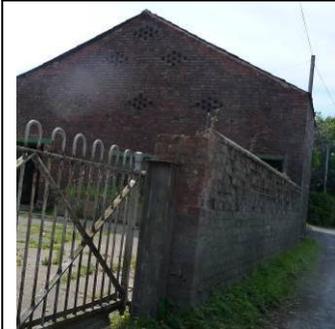
<p>Farm building on Chapel Road</p>	<p>Selected because of the positive contribution it makes to the character of the area and its link with an agricultural past</p>

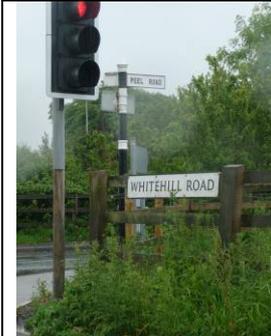
<p>Finger post on corner of Whitehill and Peel Road NGR SD35545 32862</p>	<p>1920s finger post, one of only three found in the study area and relatively rare nationally</p>

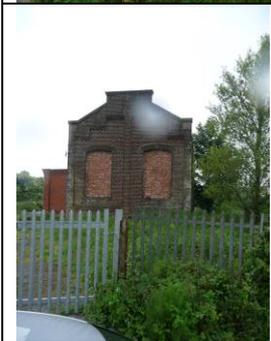
<p>Peel Road approx NGR SD 35711 32190</p>	<p>Interesting brick built building possibly late 19th century adds considerably to the historic character of an otherwise bleak landscape</p>

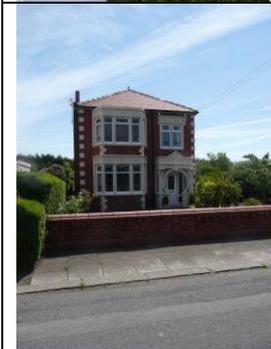
<p>Loretta? 20, Moss House Road</p>	<p>Selected for its unusual quirky 1920s? style which contributes much to the character of the area (the plastic replacement door does little to enhance the property however)</p>
